TRAILS NOW

CVNP Bridle Hiking Trails 2022:
Work Completed

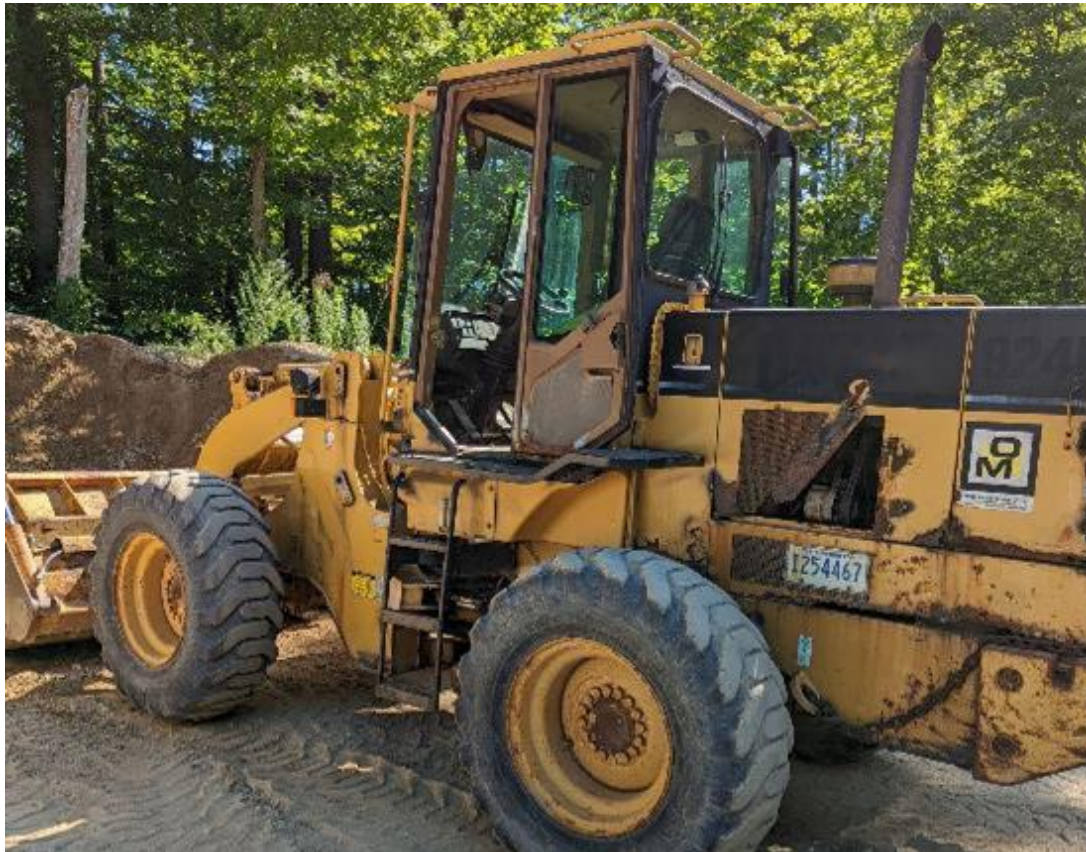
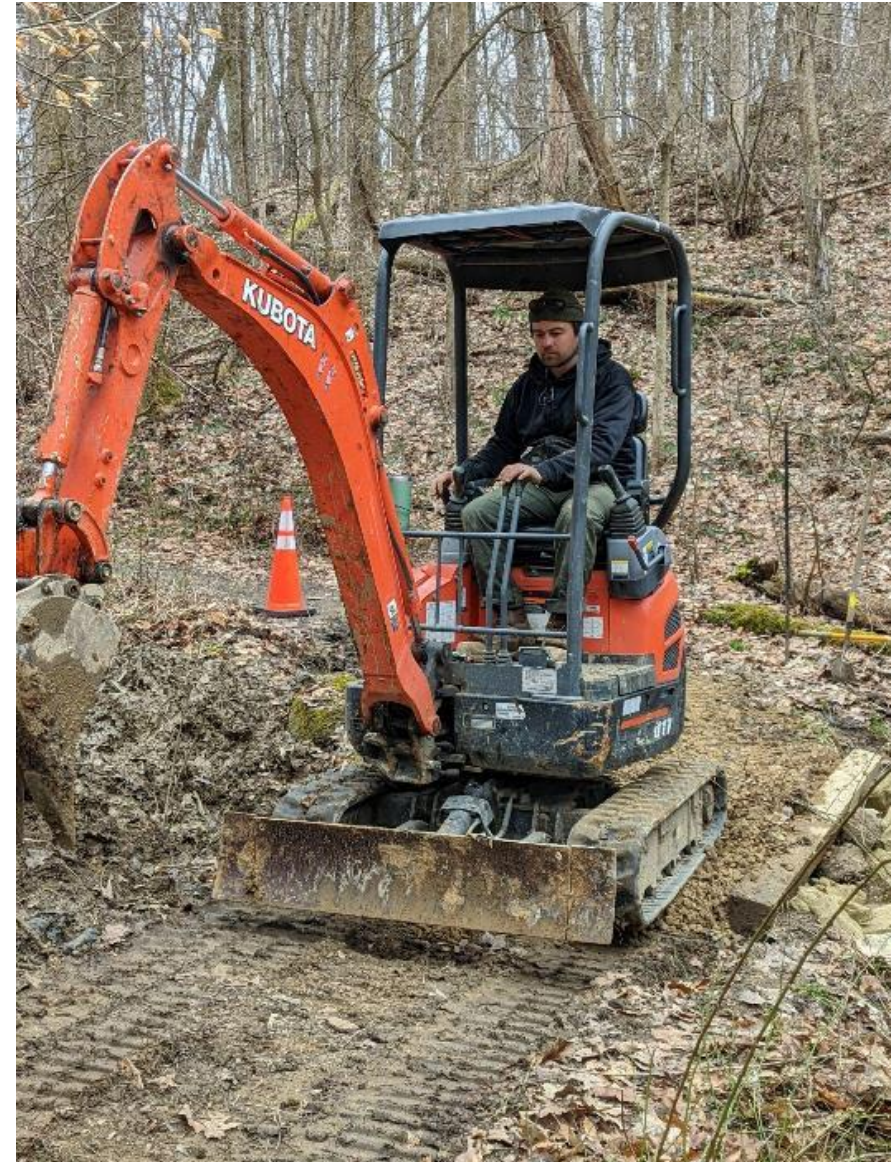
Material Transportation

The trail crew moved material onto sections of the trails that needed work, primarily using UTVs on flat sections and power wheelbarrows on steeper sections.

Toward the end of the season, the park's equipment operator helped with some of the difficult hilly sections, which saved time and expedited work.

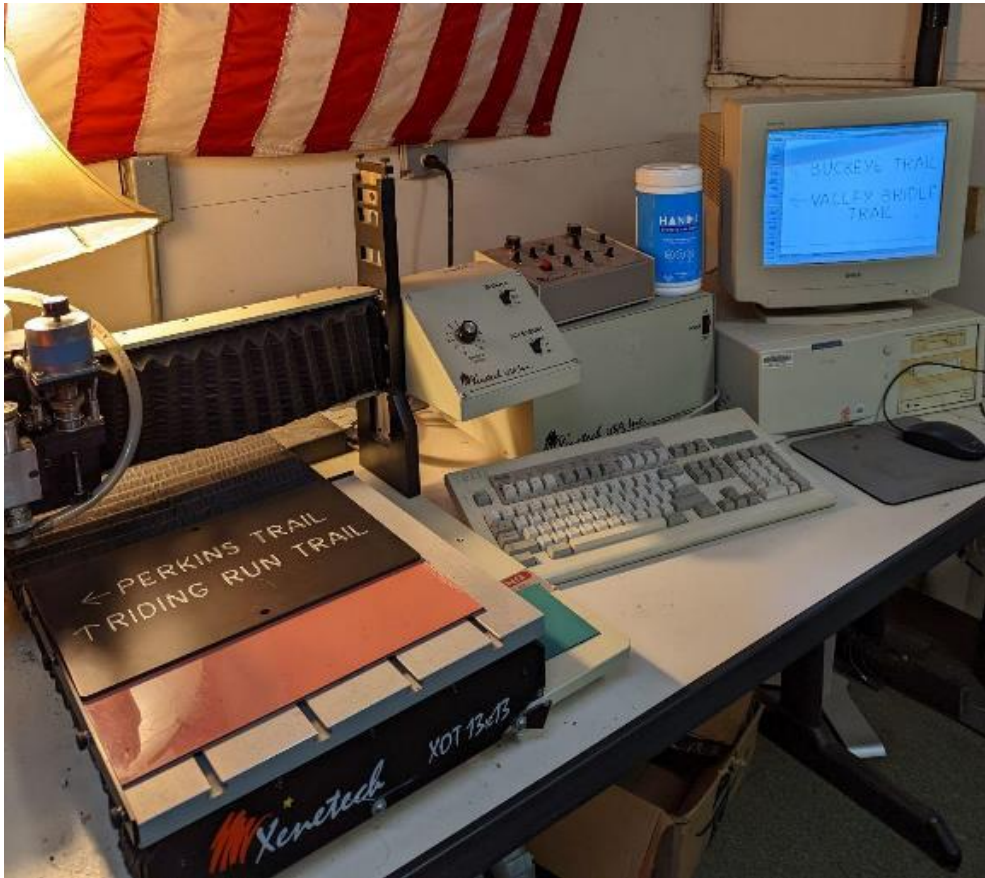
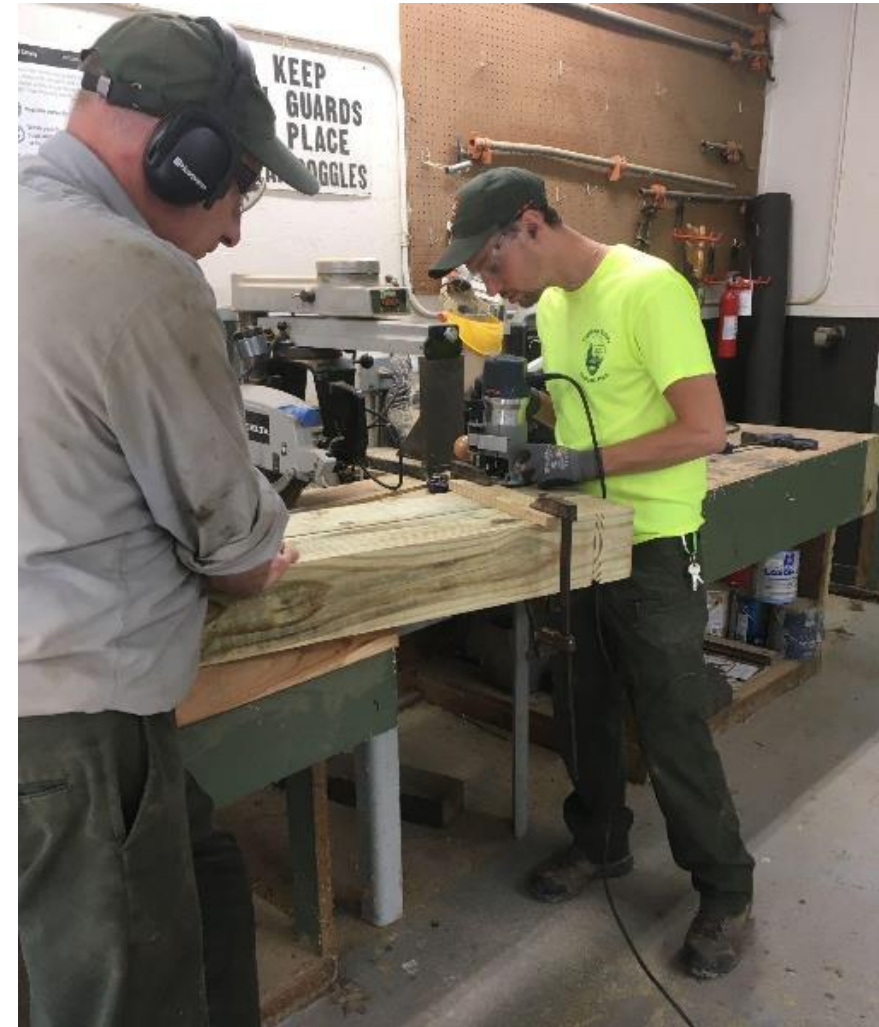
Sign Making

NPS is in the process of updating park signage on the trails from wood to metal. Metal is more durable and will not degrade over time.

New signage posts are being made to replace rotten ones.

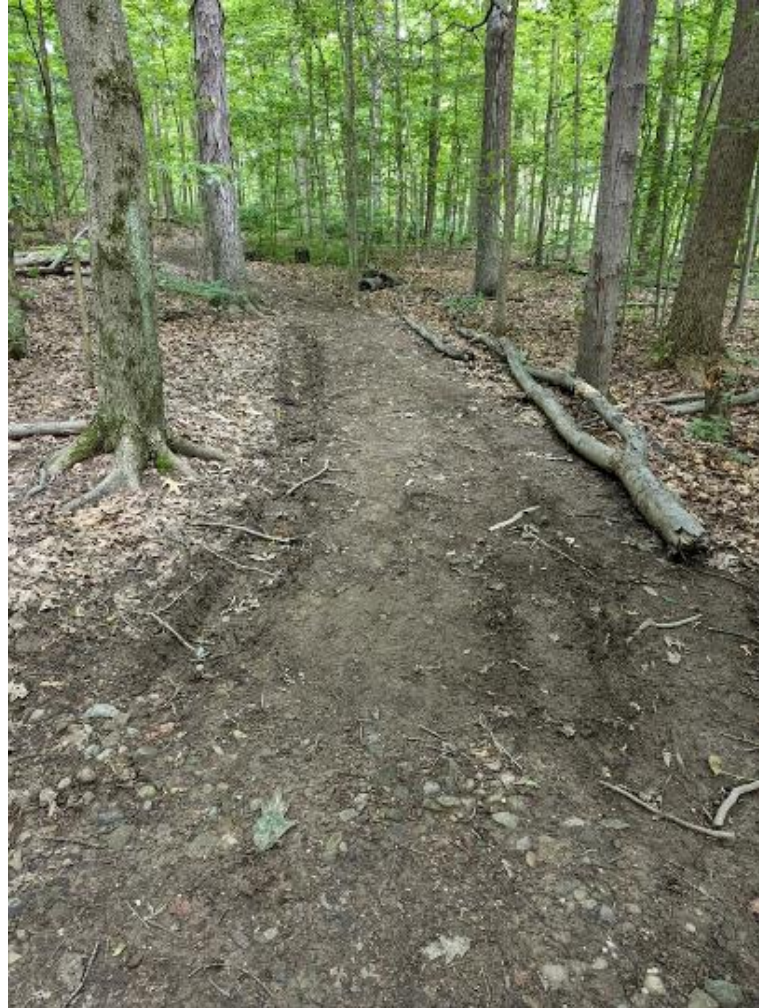
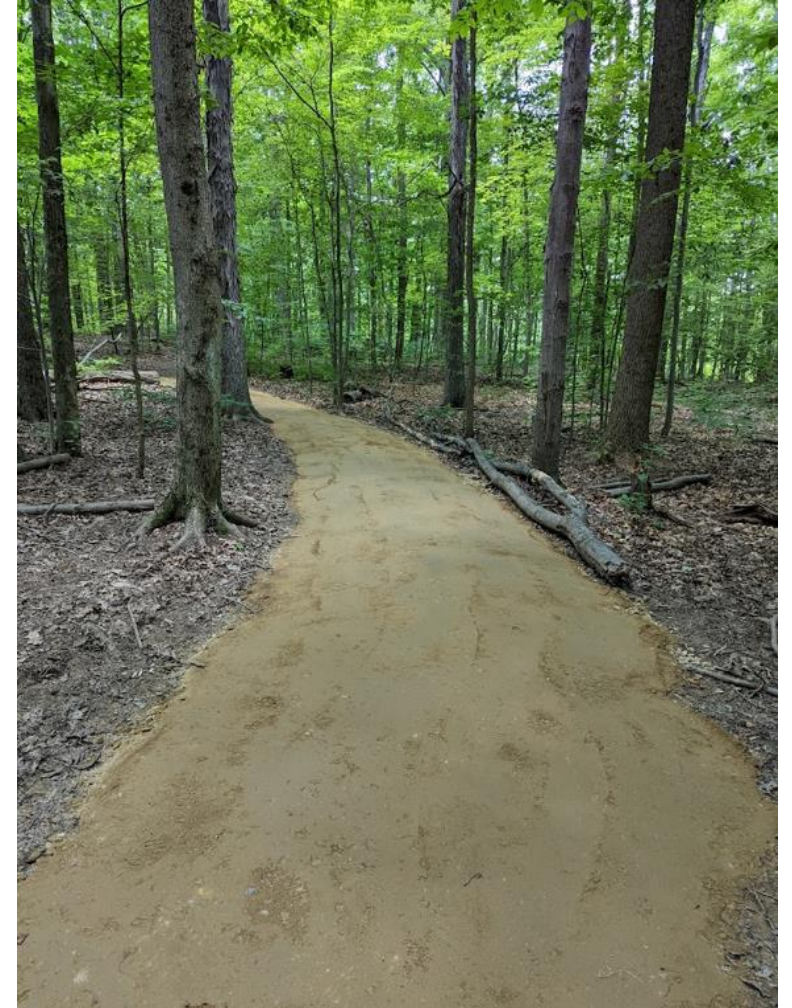
Tread Armoring

The trail crew hardened tread throughout the season.

This practice minimizes maintenance and stabilizes the surface for use impact. It also minimizes erosion and drainage impacts to natural resources.

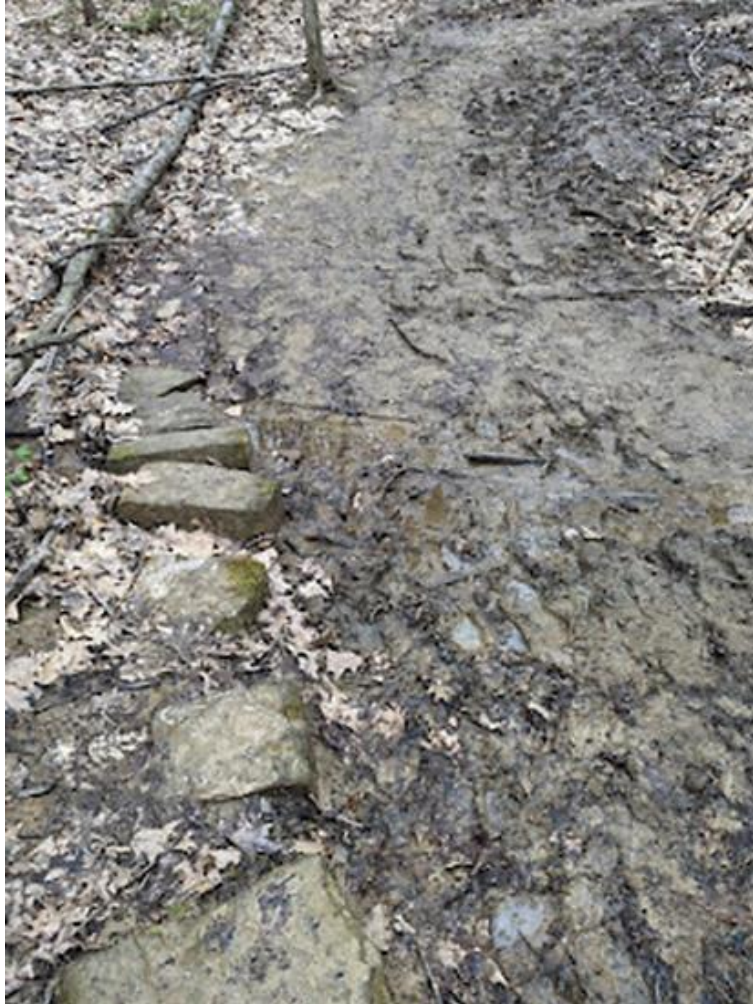
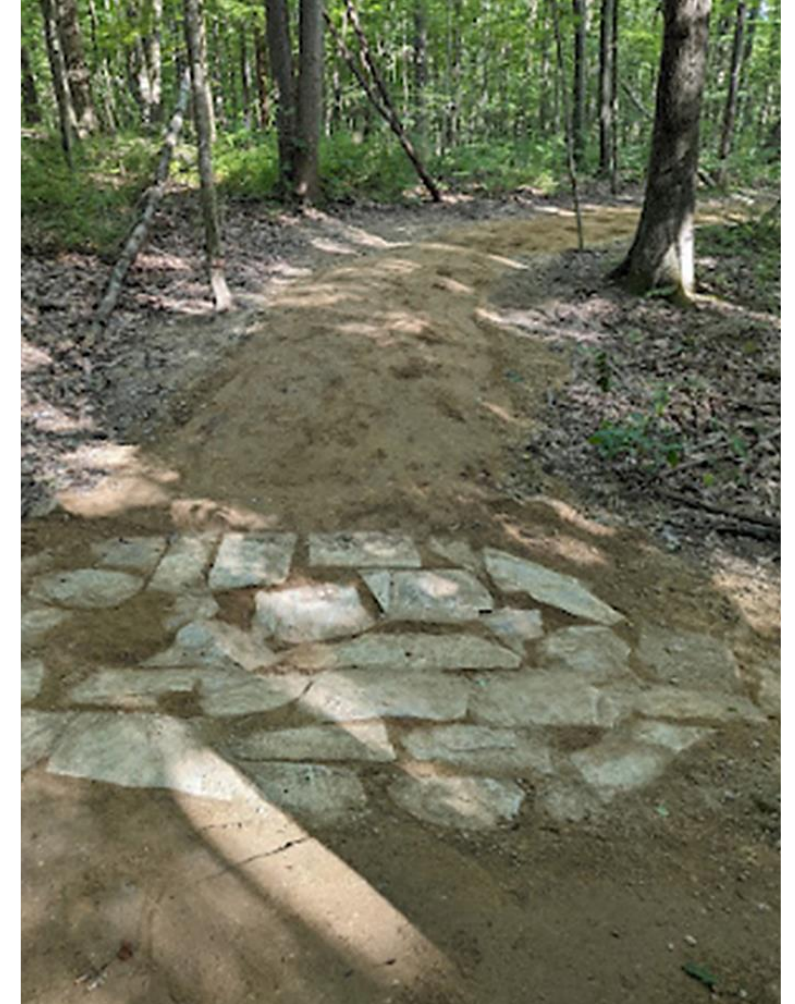
Hardened Tread Crossing

This section of the trail has spring runoff and flowing water during heavy rainstorms.

The trail crew installed large, flat stones to encourage water to pass through, providing a stable surface to cross.

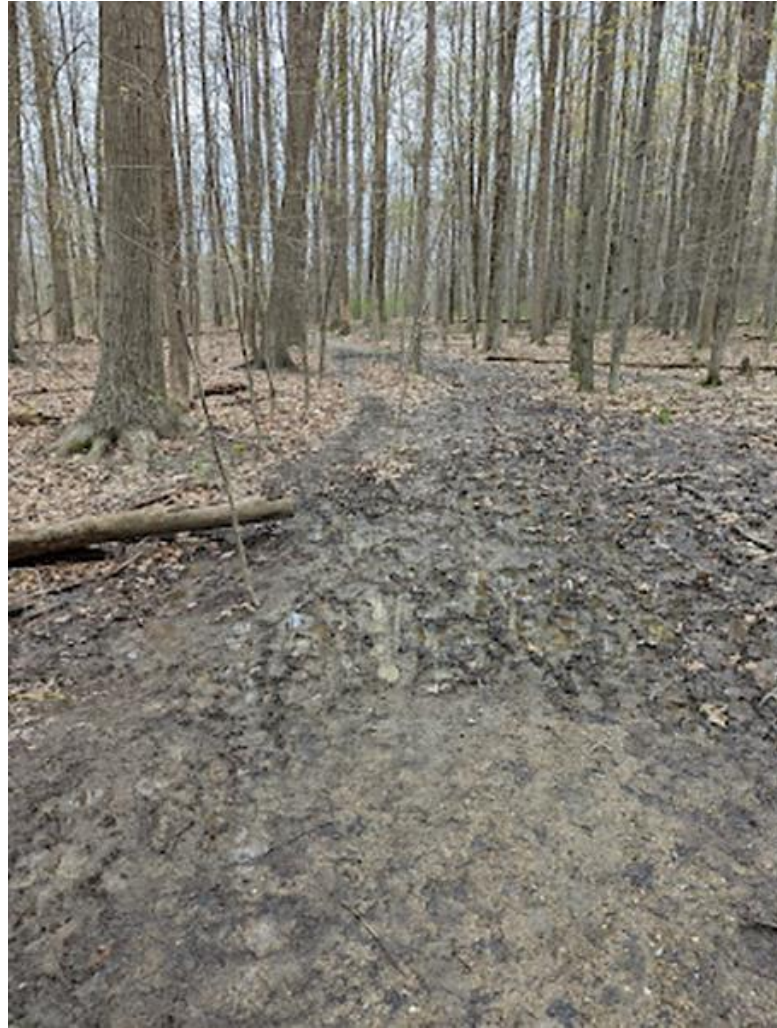
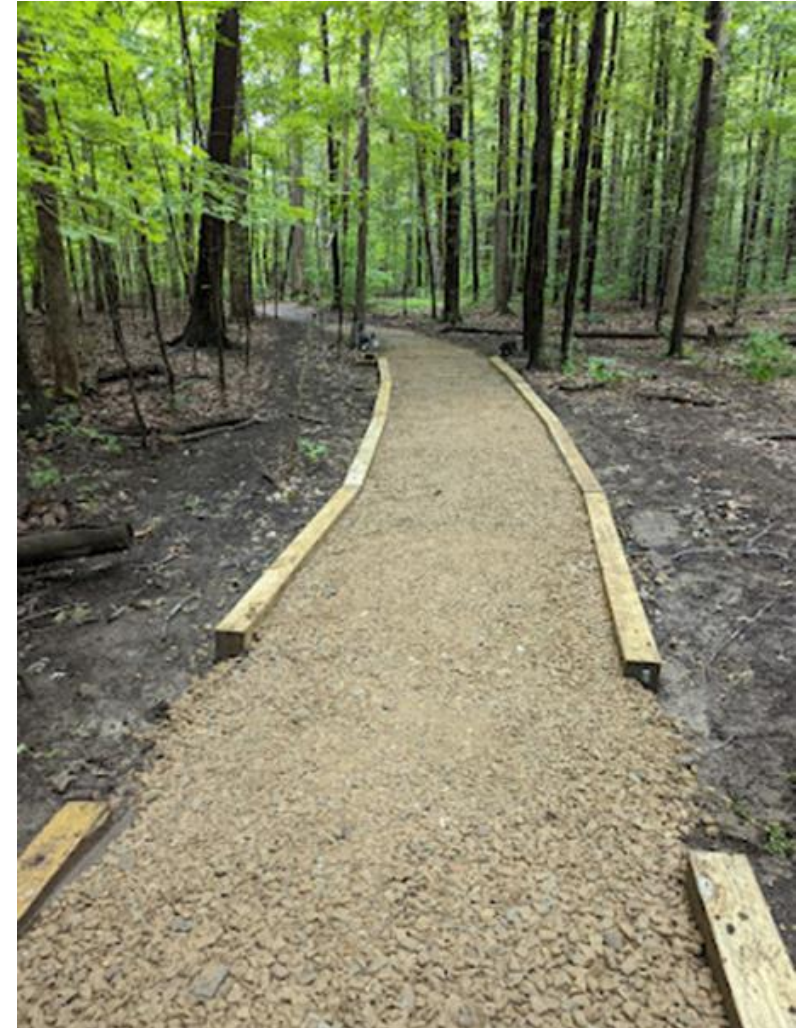
Turnpikes

The trail crew used turnpike construction in areas where the trail tread remains very wet during the year and relocation options are not available.

This section was a perfect spot for turnpike construction.

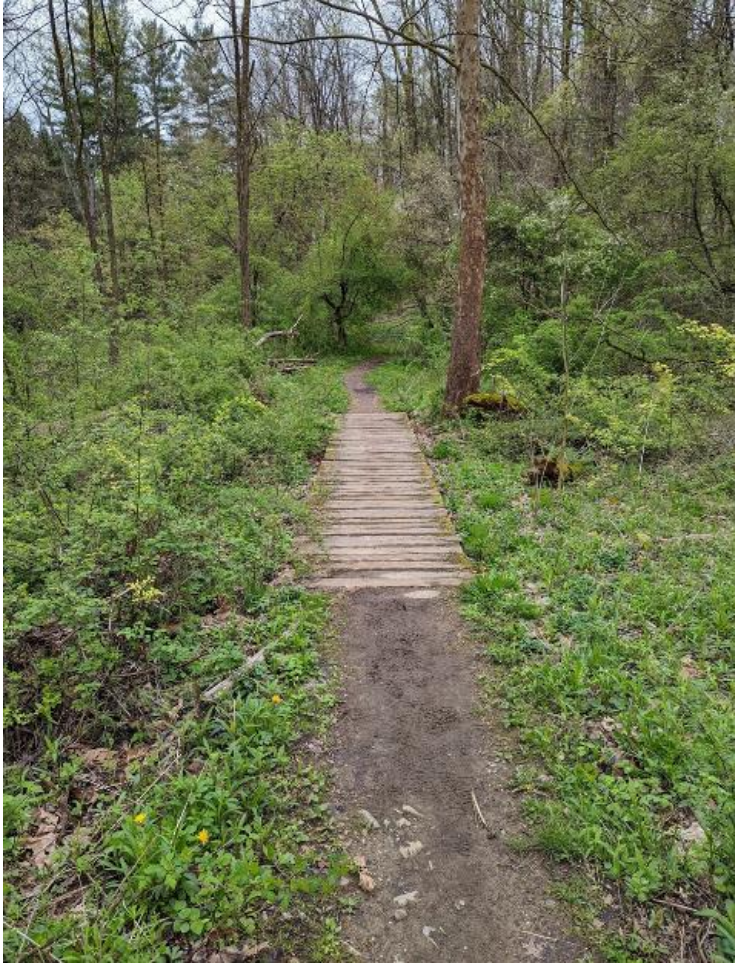
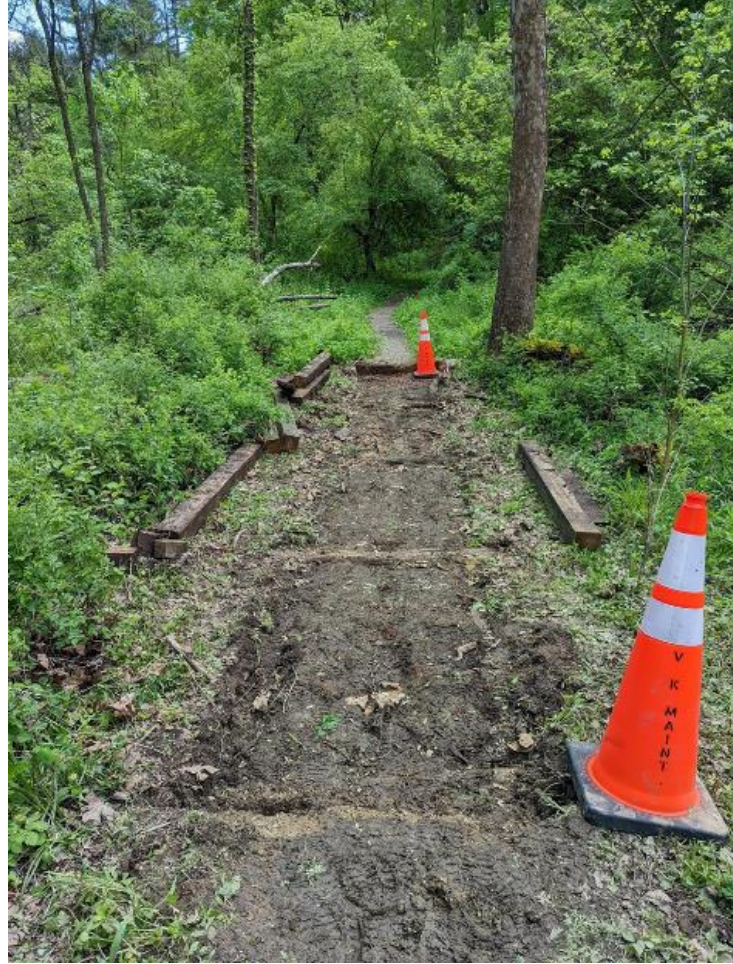
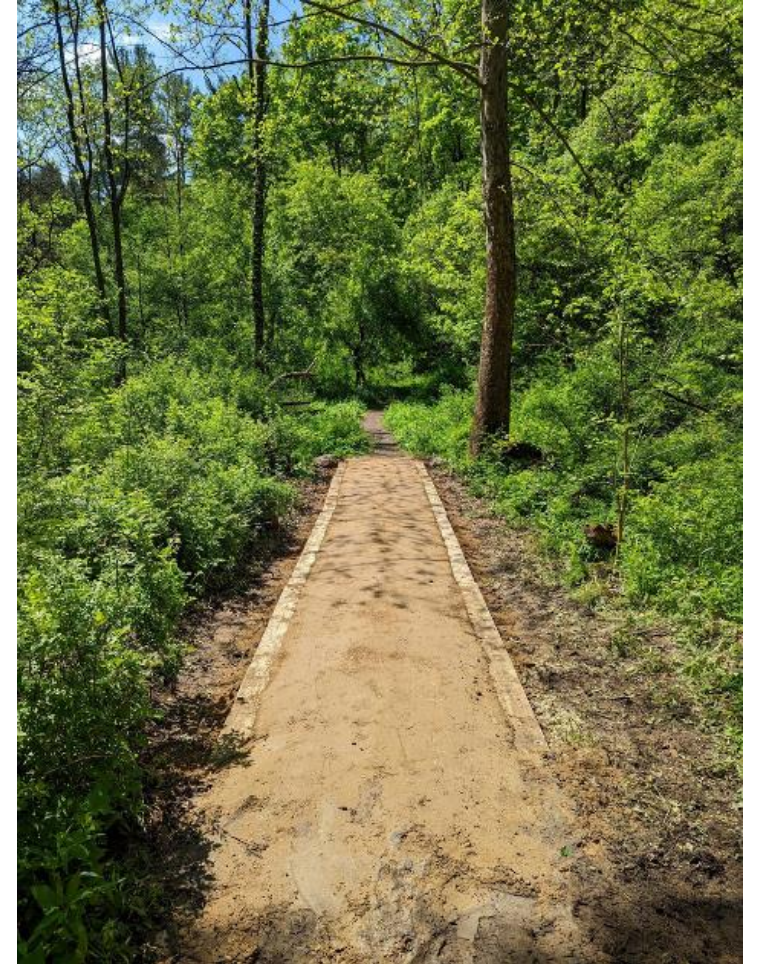
Decaying Boardwalk to Turnpike

The decaying boardwalk was a concern. The trail crew removed it and installed a new 30 foot turnpike. Installing the turnpike raised the tread and created a stable, dry path for both horses and people.

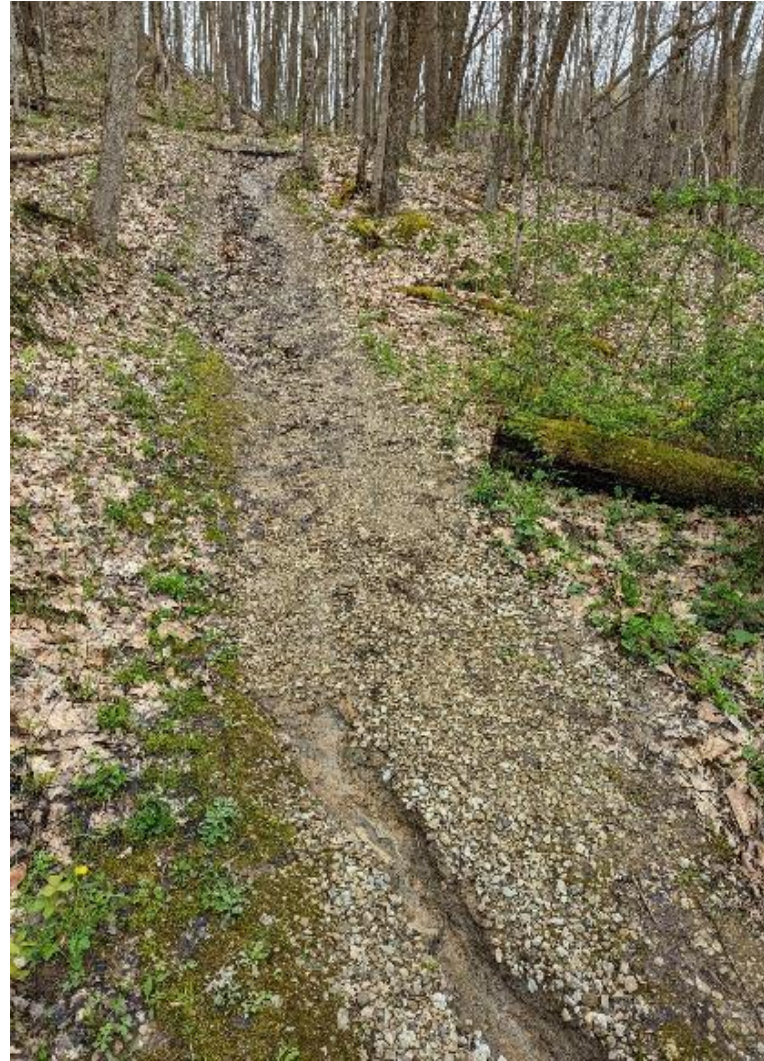
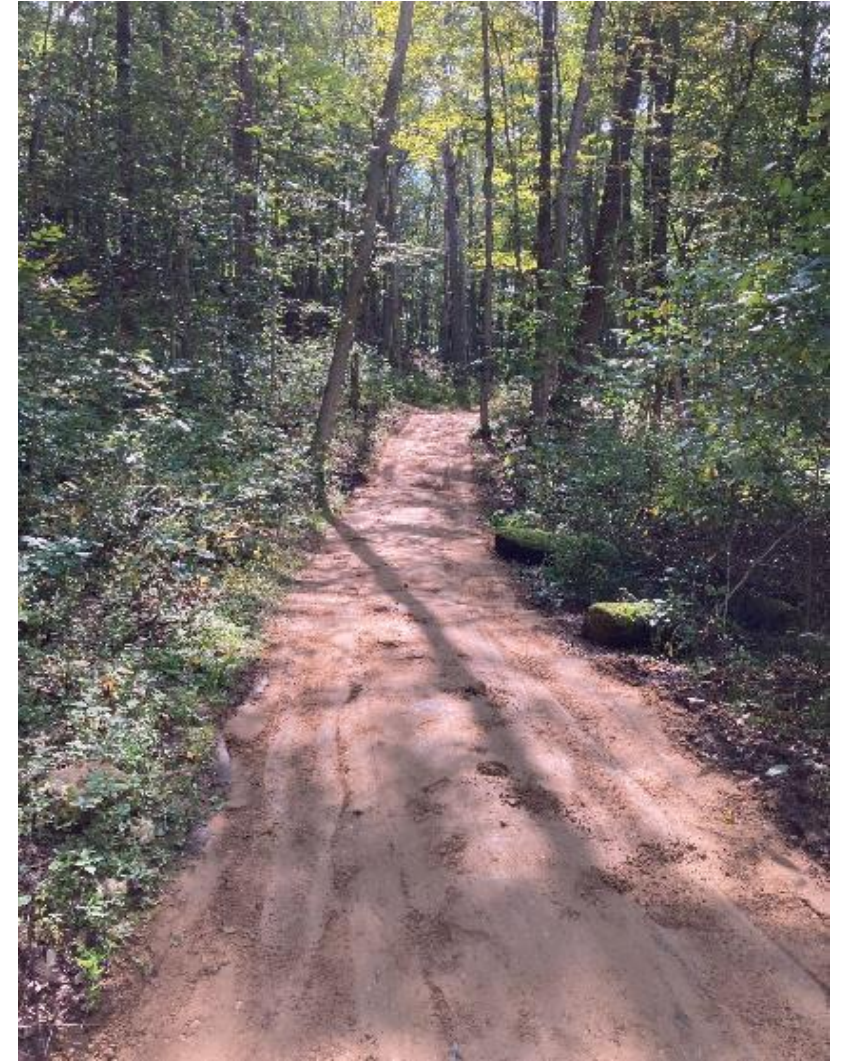
Trenched Out Trail

This portion of the trail was divided in half by a foot-deep trench.

To encourage water to flow off the trail, the trail crew reworked the grade, created drains and dips, and topped it off with stone and trail mix.

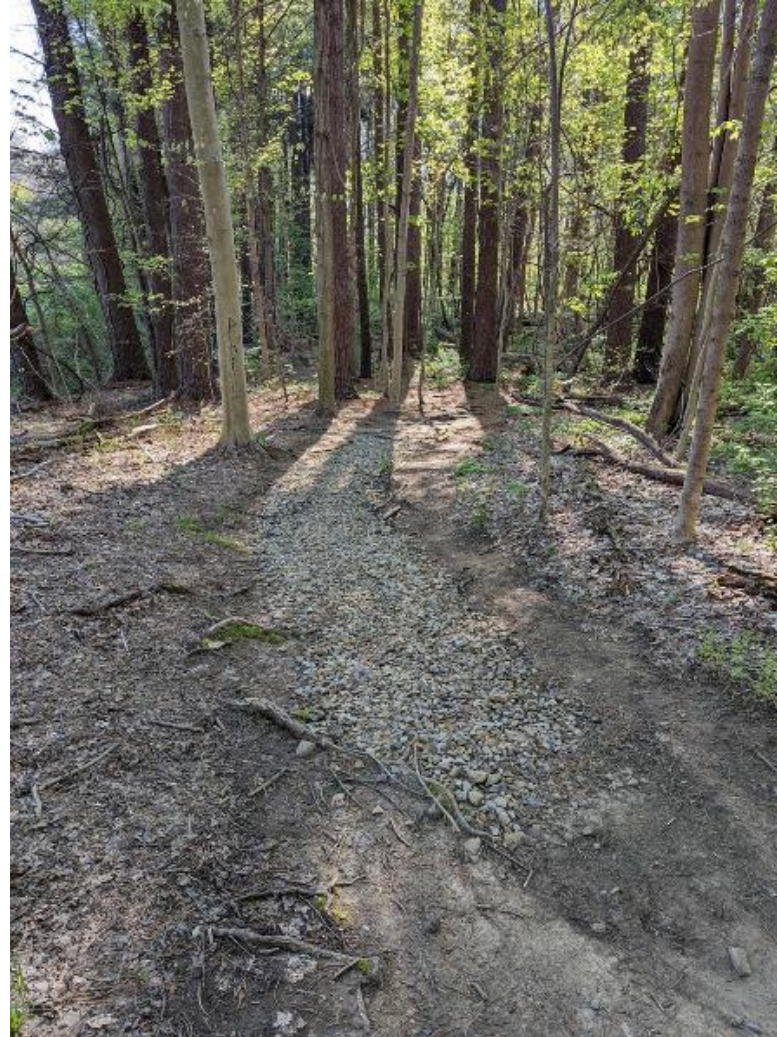
Surface Maintenance

Mixed aggregate was used on trail portions located on flat terrain with poor drainage.

It was also used in areas where the use of dips and reversals were not feasible.

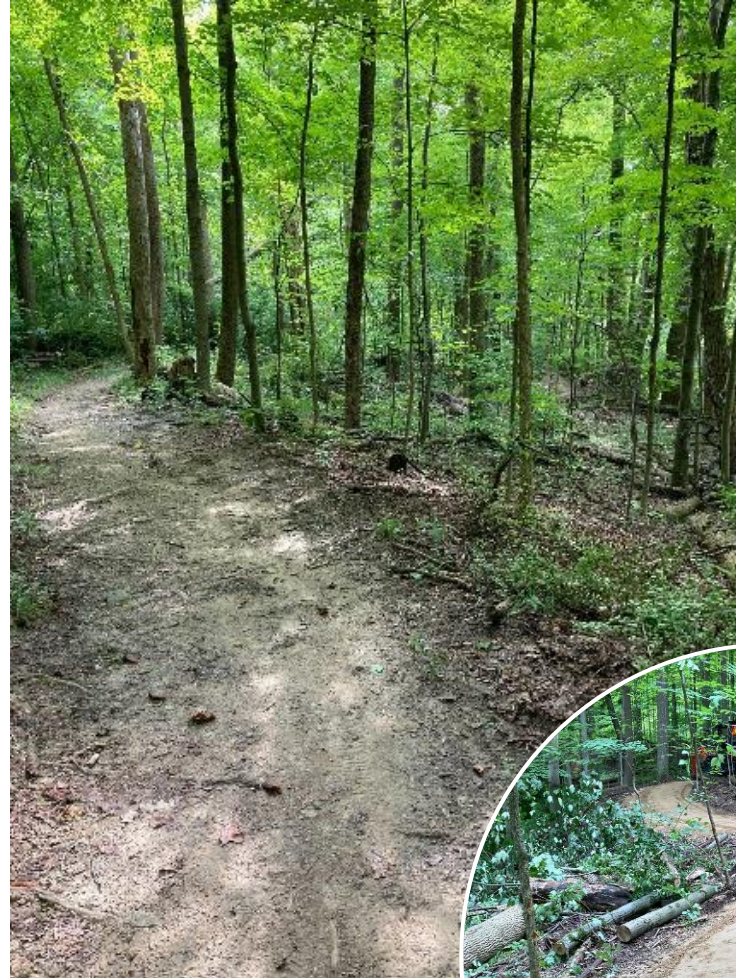
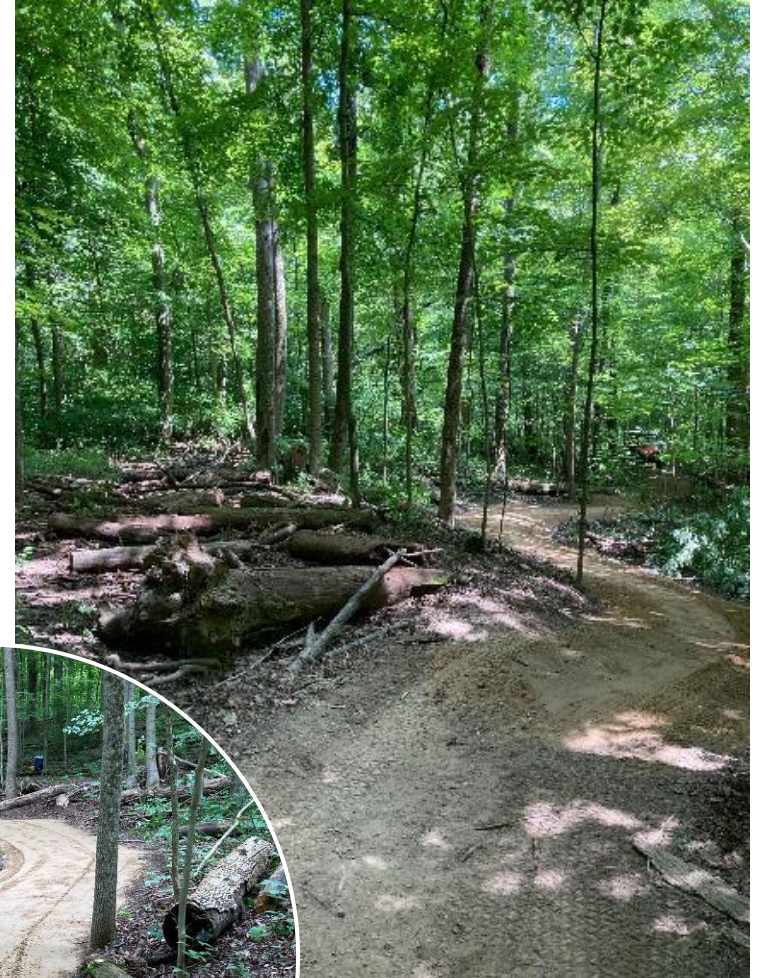
Trail Reroute

The old section of this trail had unsustainable drainage conditions. It was closed off and rehabbed.

The trail crew constructed a new section of trail with a proper grade reversal and cross slope to ensure drainage.

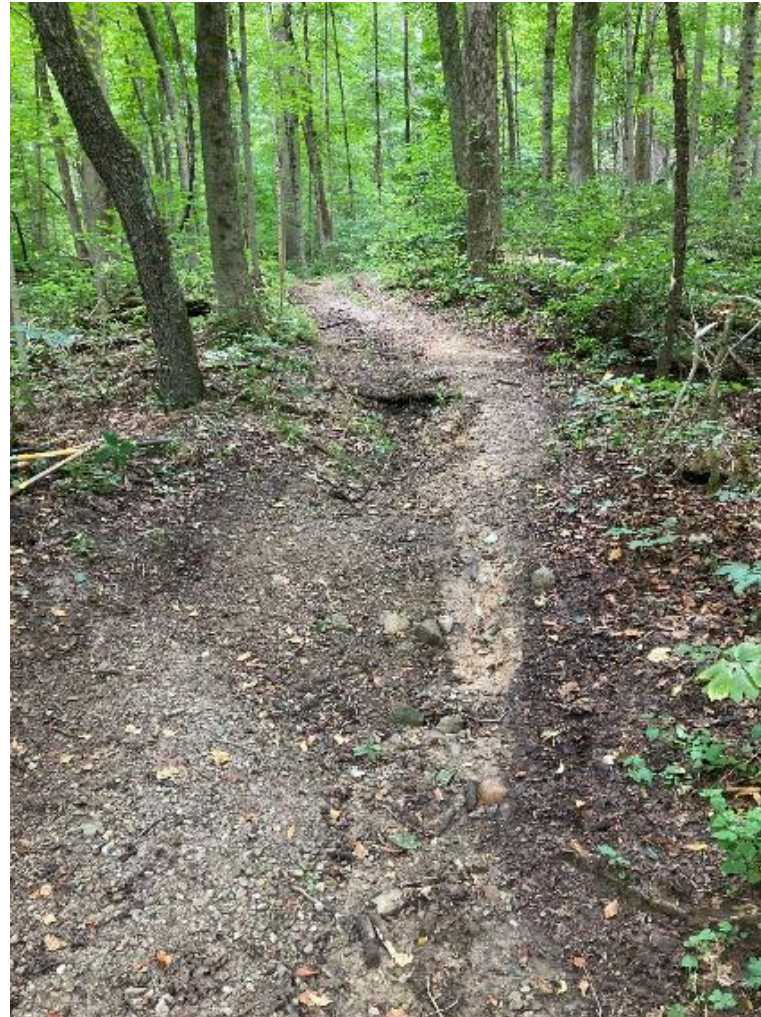
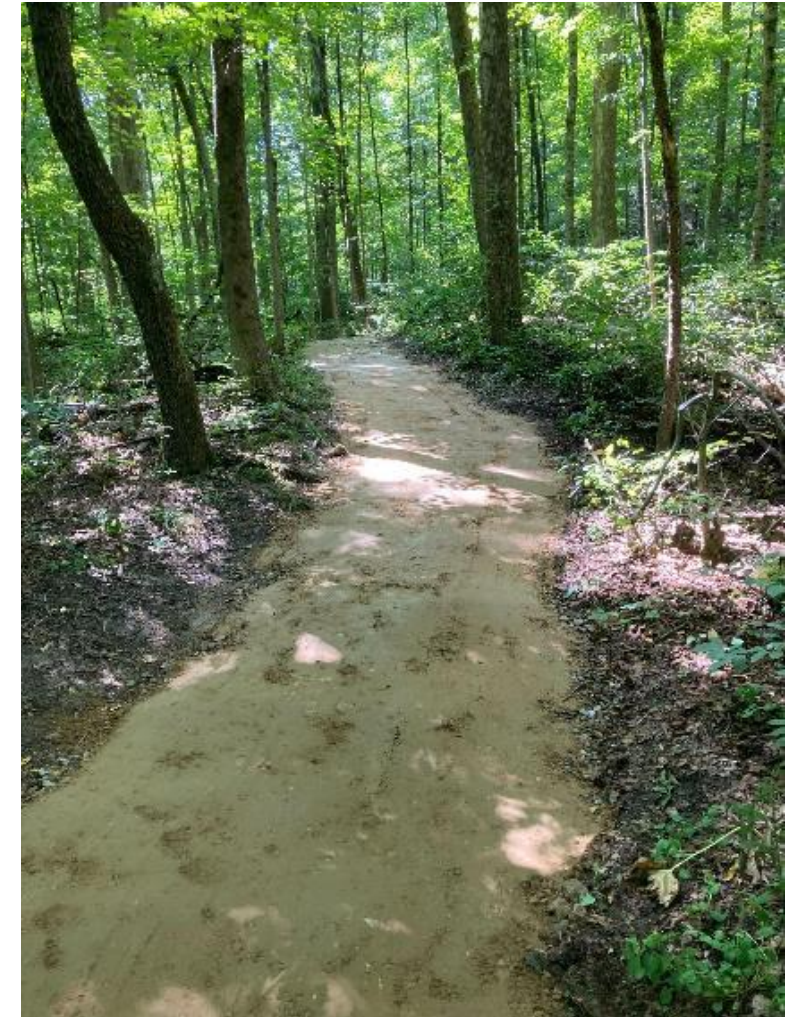
Trenched Out Hill

This section of trail was trenched out due to water running straight down the trail.

The trail crew mitigated this issue by creating drainages and adding material.

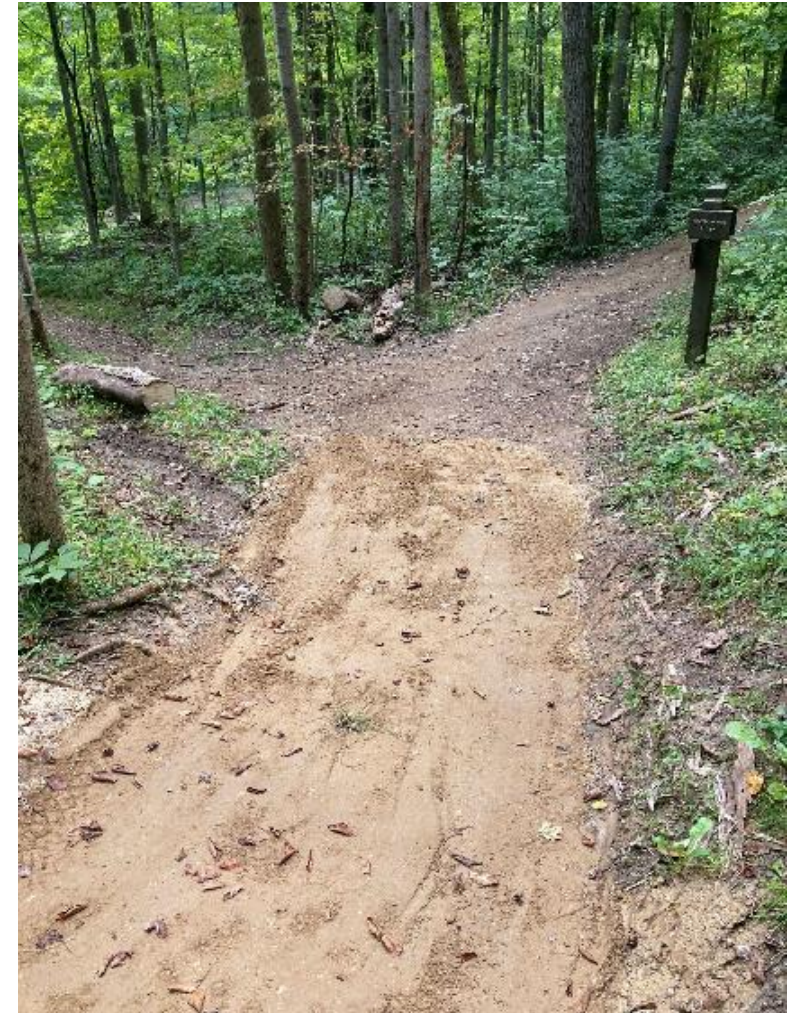
Creating a Drain

By clearing out a downed tree in the drain and digging out a passage for water, this section of trail is no longer muddy.

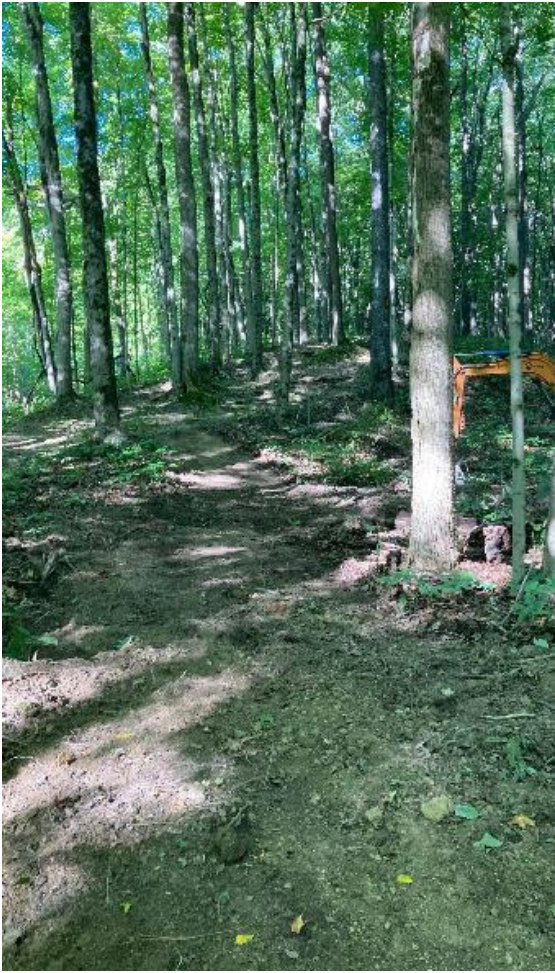
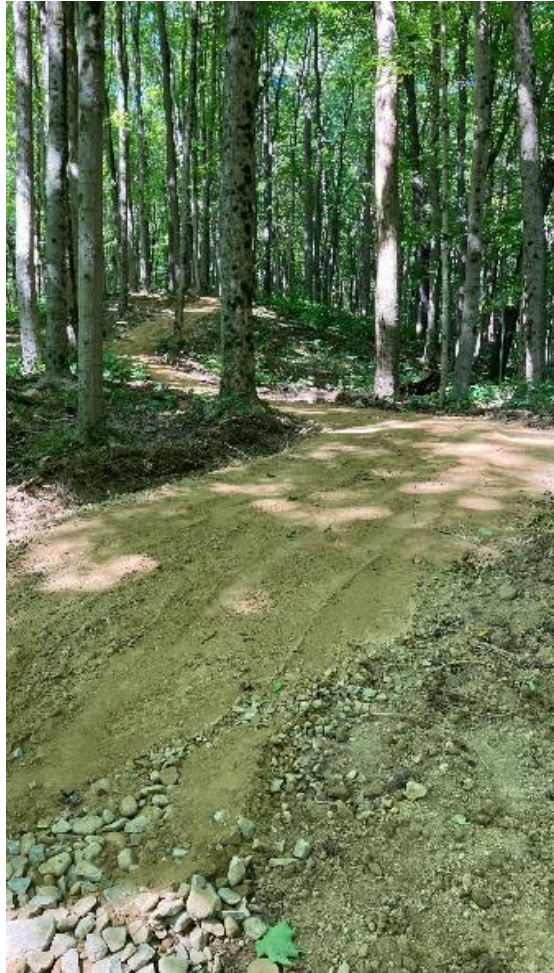
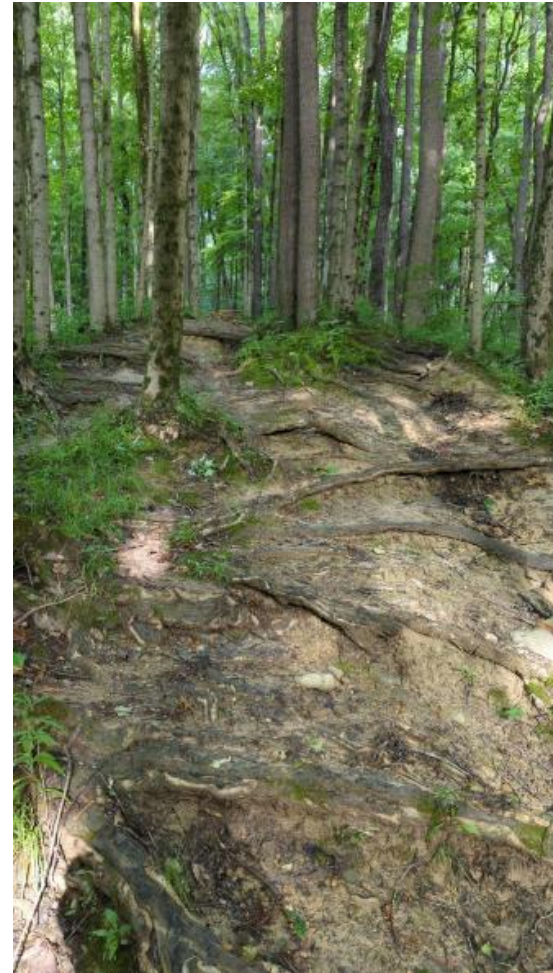
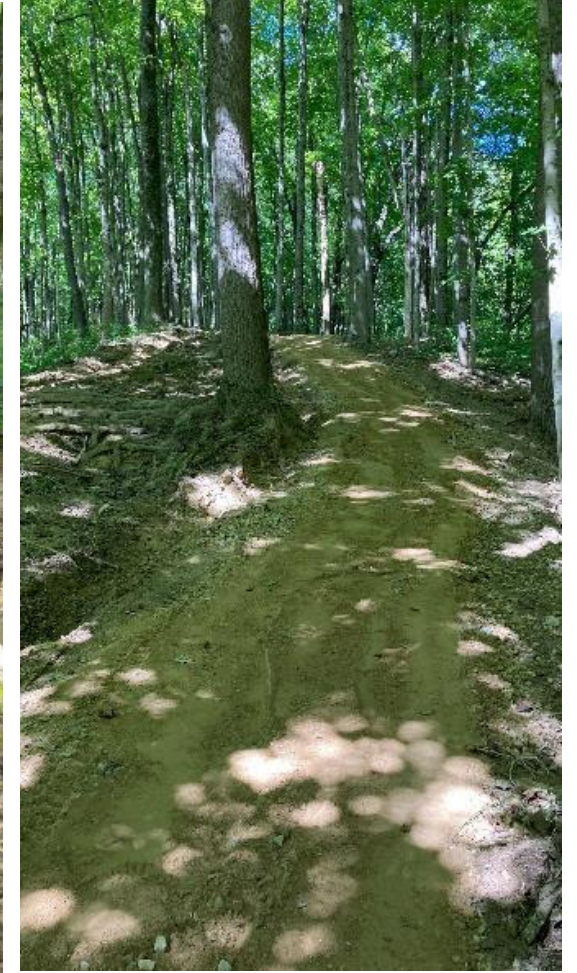
Regrading the “Big Hill”

This section of the trail was eroded and had many exposed roots and trail braids. To solve these issues, the trail crew shifted the trail, regraded it, installed drainage dips, and topped it off with stone and trail mix.

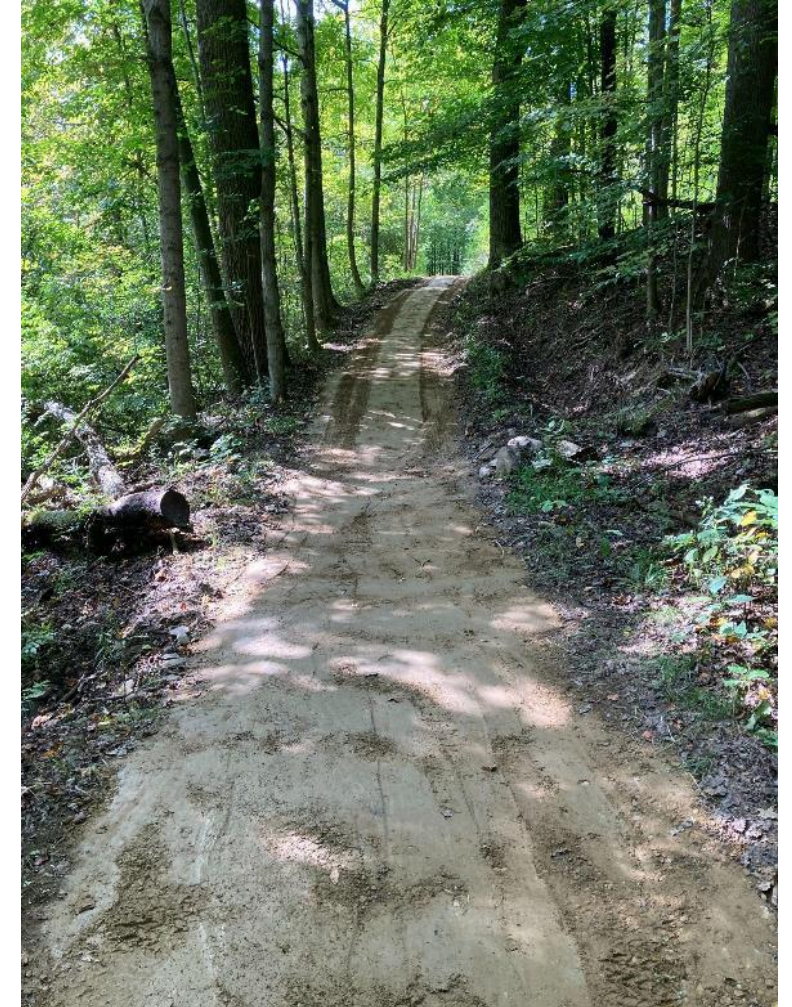
Removing the Dreaded Check Steps

Since this trail is primarily used by equestrian riders, check steps were removed for safety reasons.

The grade of the hill was also inadequate, so it was regraded and drainage was improved.

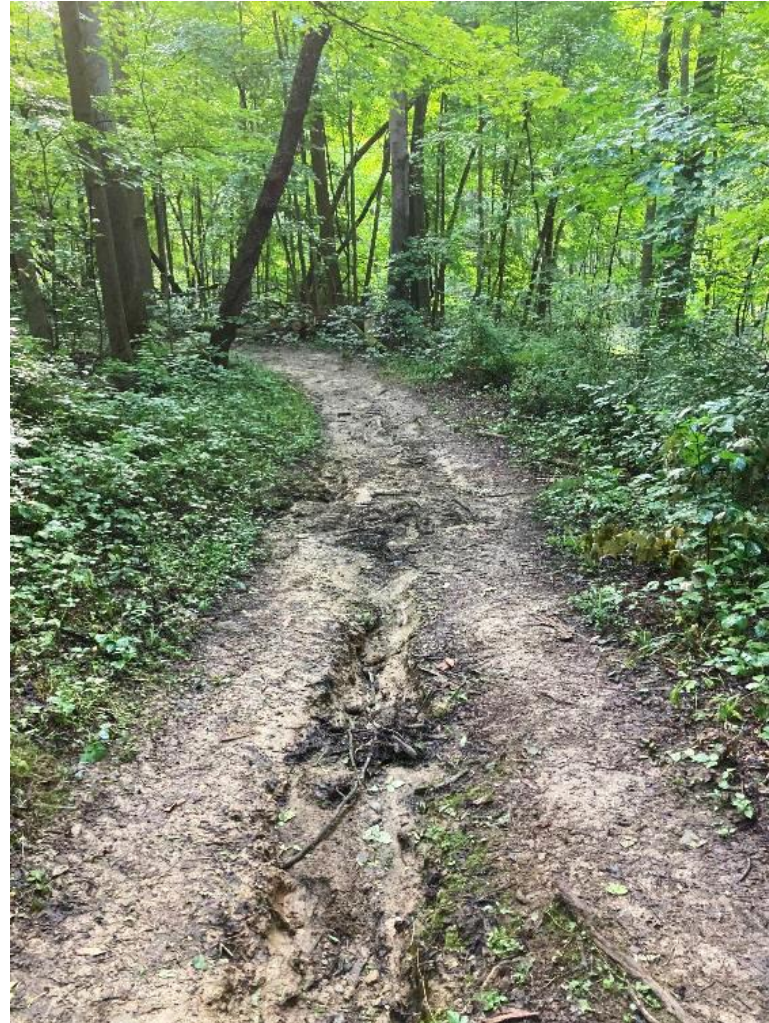
Fall Line Trail Trenching

Most of the Riding Run Trail was trenching out due to lack of sustainable drainages.

This was remedied by adding drains, crests, dips, and trail material.

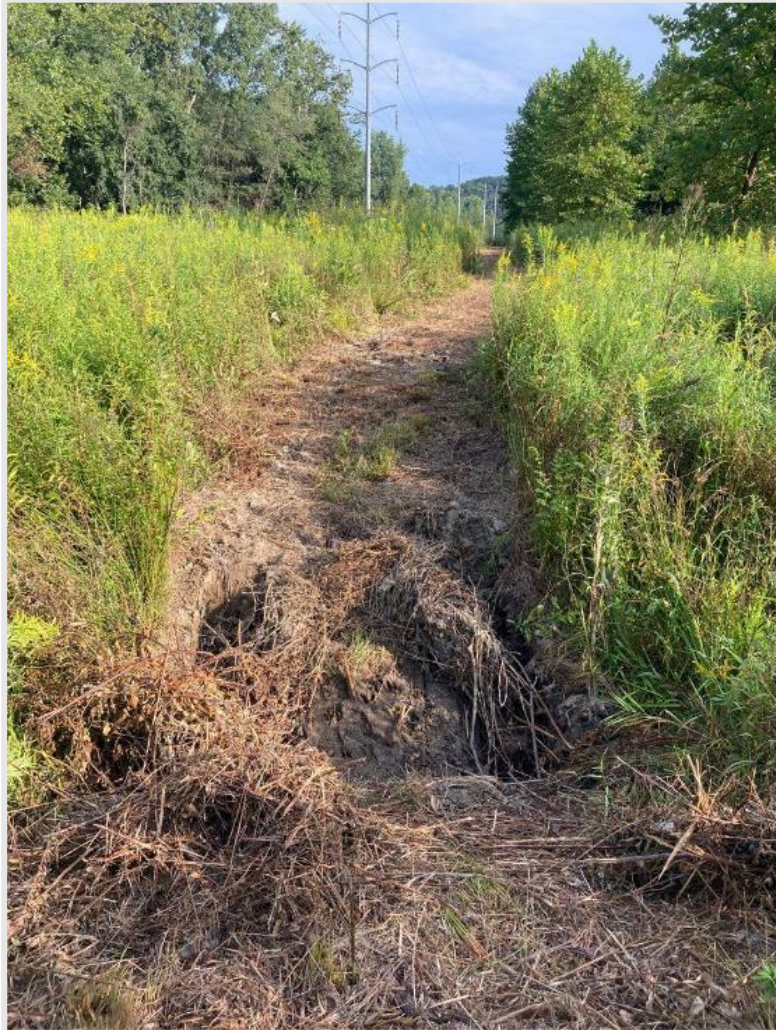
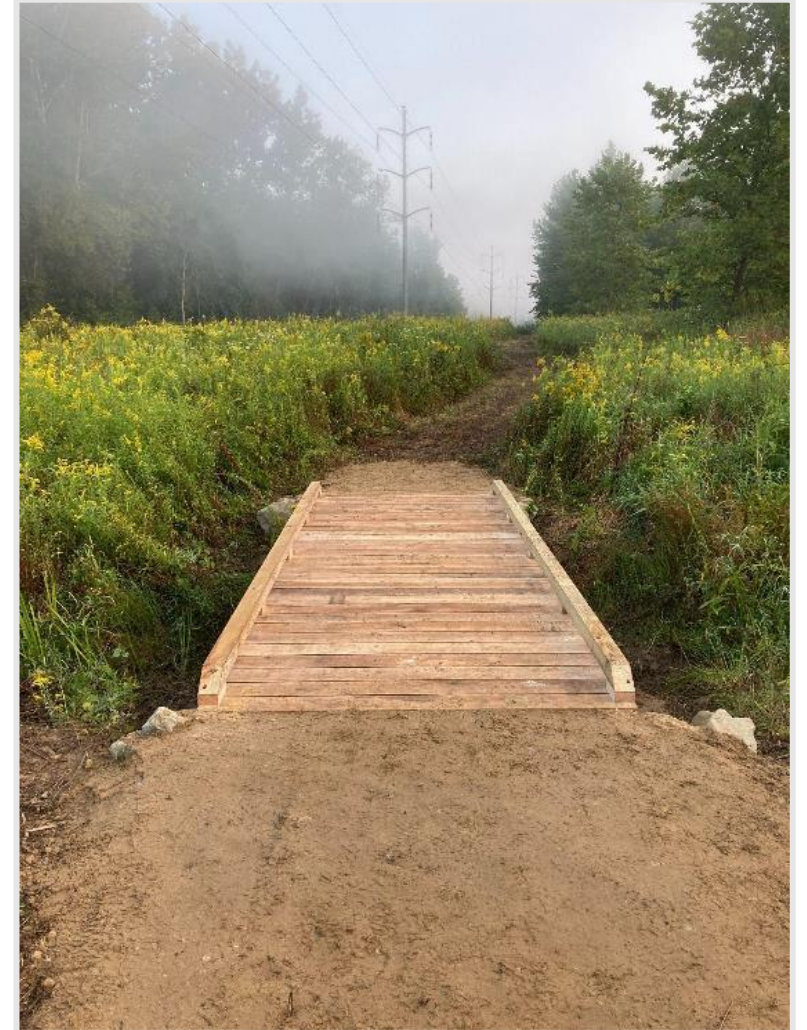
Installing a New Bridge

Once passable, this ditch degraded over time, making it difficult to cross.

Since avoiding the ditch was not possible, the trail crew built a bridge to cross it.
