TRAILS NOW

CVNP Bridle Hiking Trails 2022:
Work Completed

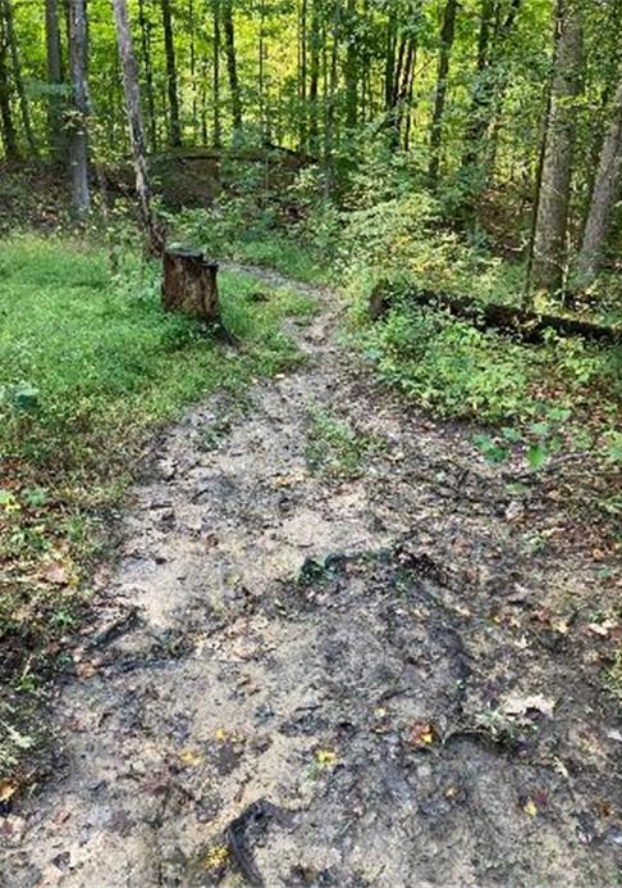
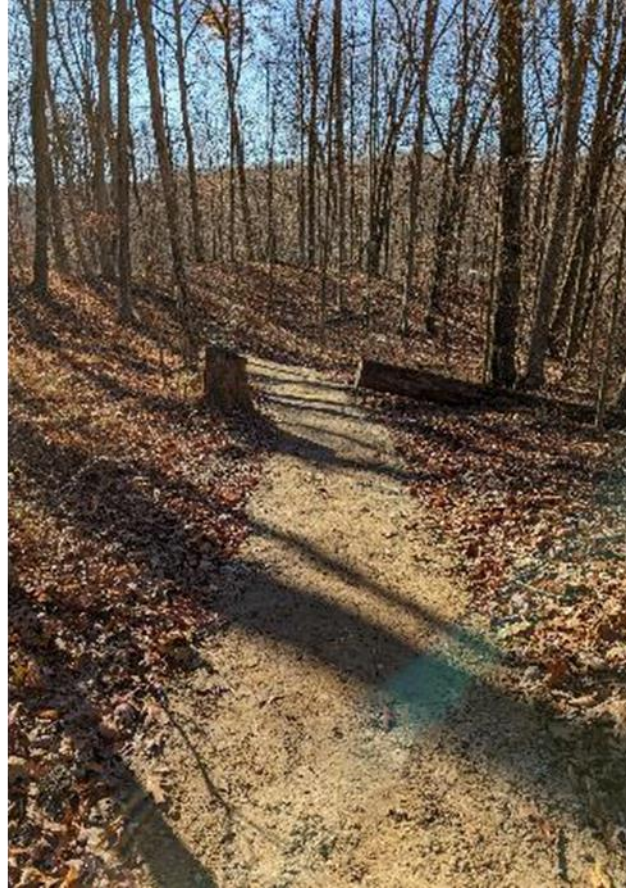
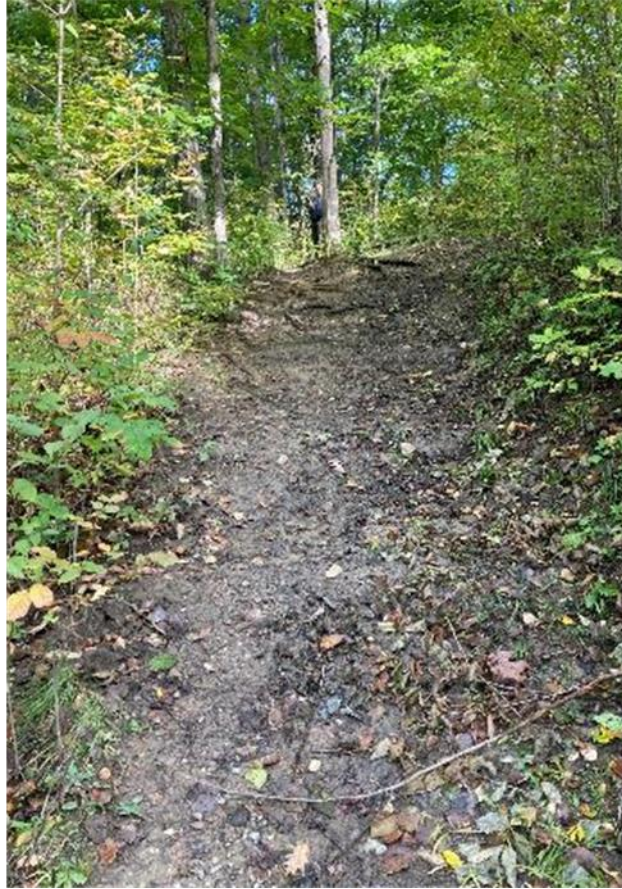
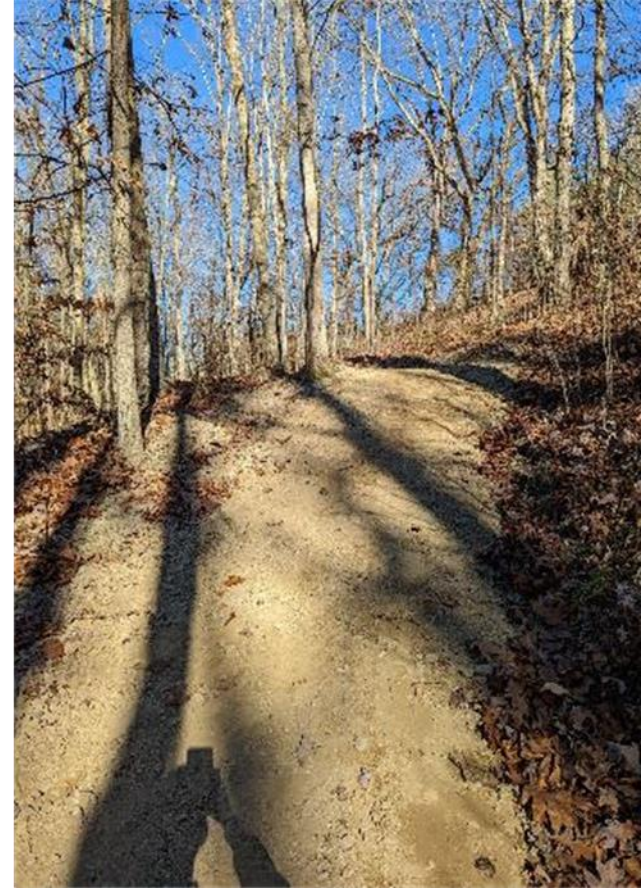
Hill Near Spicy Lamb Farm

The hilly section of the Valley Trail was improved. It had poor drainage, trenched out areas, and significant mud. The park's equipment operator regraded, removed berm formations, and added effective drainage. The trail crew then added stone and trail mix for the finish.

Berms are made of soil that has built up on the outside of the trail tread. They form when water erodes tread that wasn't compacted during construction, depositing it on the edge of the trail. This creates a barrier that prevents water from sheeting off. When water runs down the tread, it gathers volume and soil as it goes.

Berm formation is the single largest contributor to erosion of the tread. Removing berms is always the best practice.

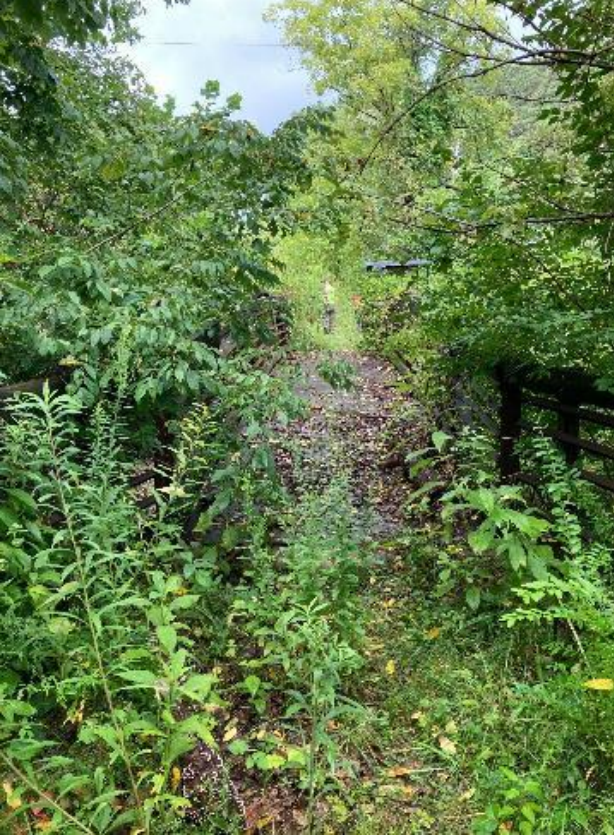
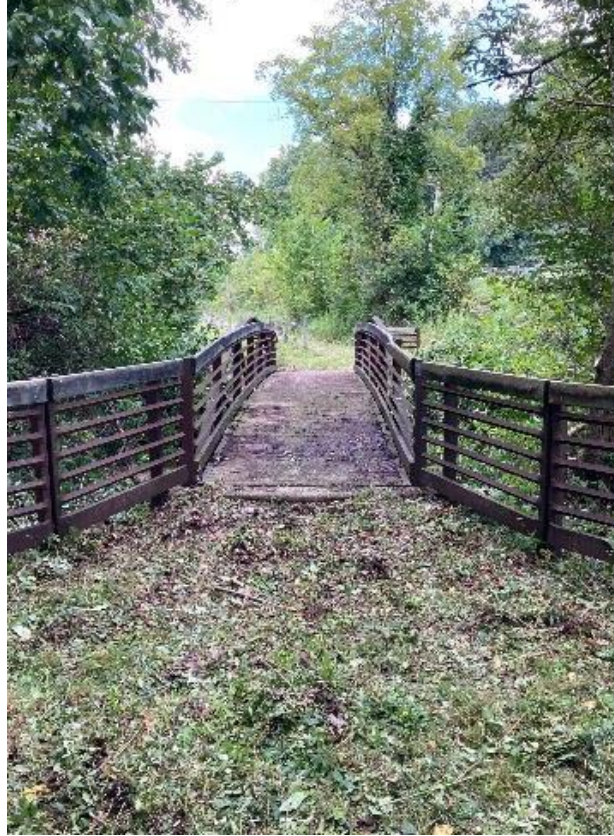
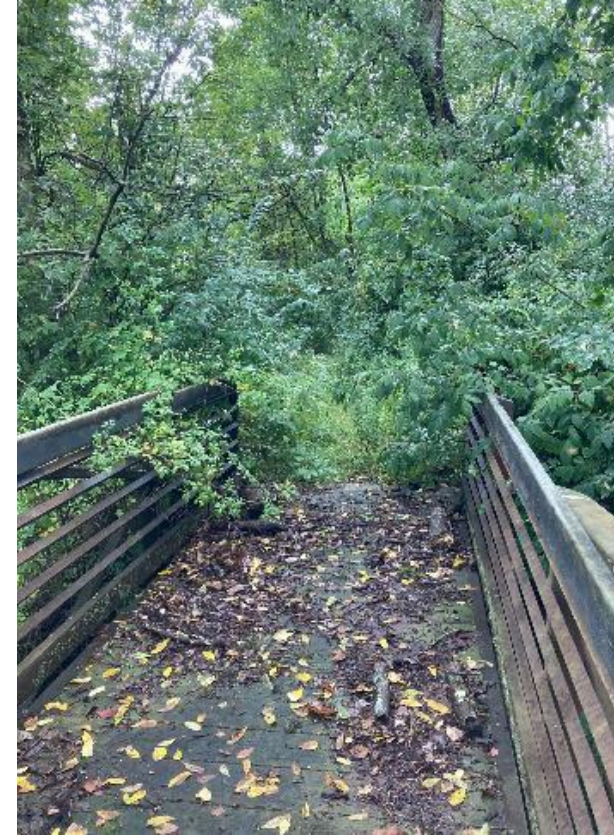
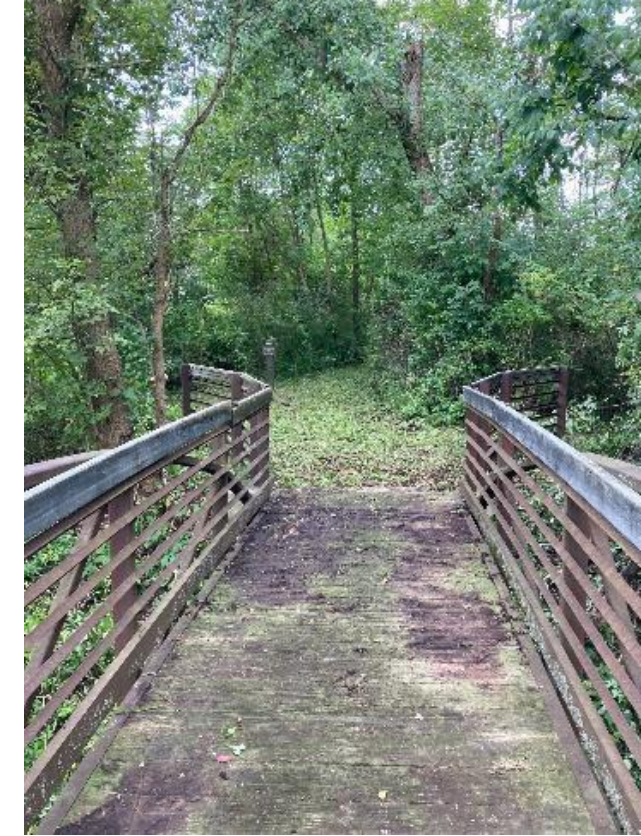
Brush Clearing

This section of the Valley Trail needed a lot of attention after being closed since early 2021.

Special attention was taken to make sure the overhead clearance (10 feet) is clear for horseback riders.

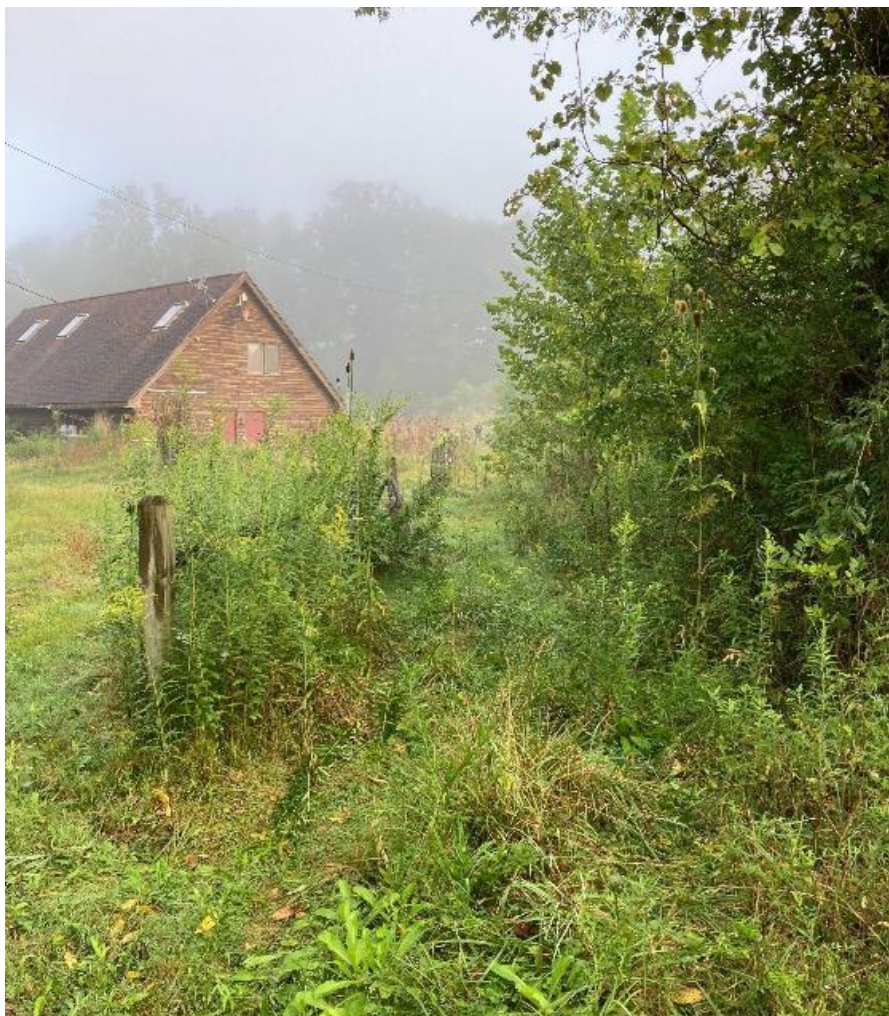
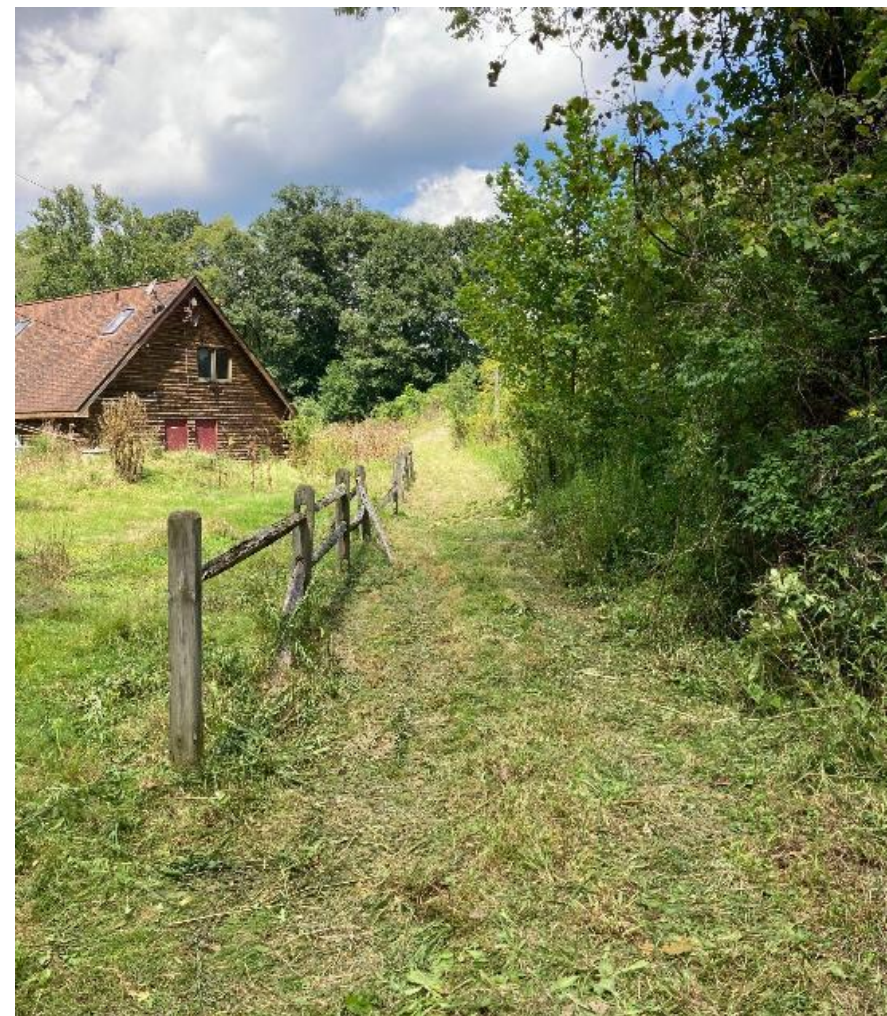
Brush was cleared at the old golf course.

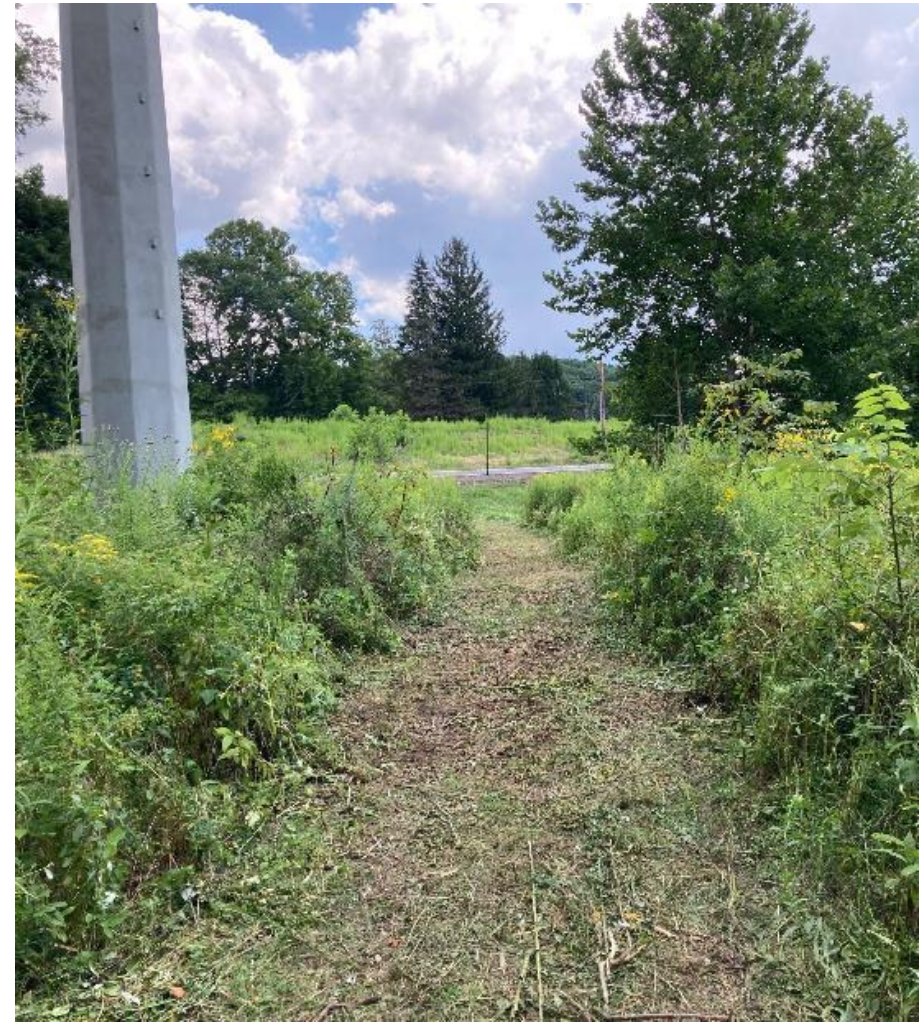
Brush was also cleared near Akron-Peninsula Road.

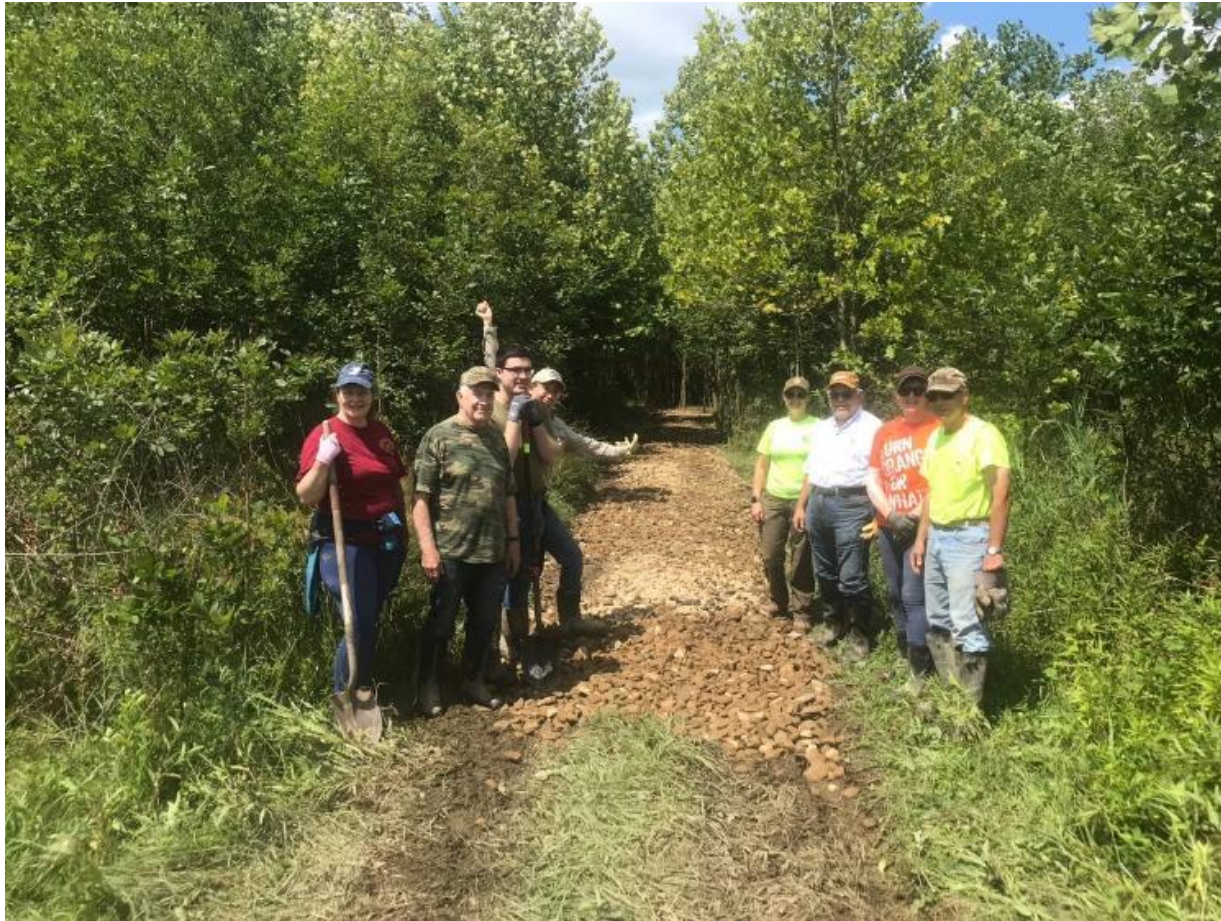
Flooded Trail Adjacent to Akron-Peninsula Rd.

This closed section of trail was severely flooded due to beaver activity.

To reopen the trail, OHC assisted the trail crew in a creative solution to create a useable passage through the water.

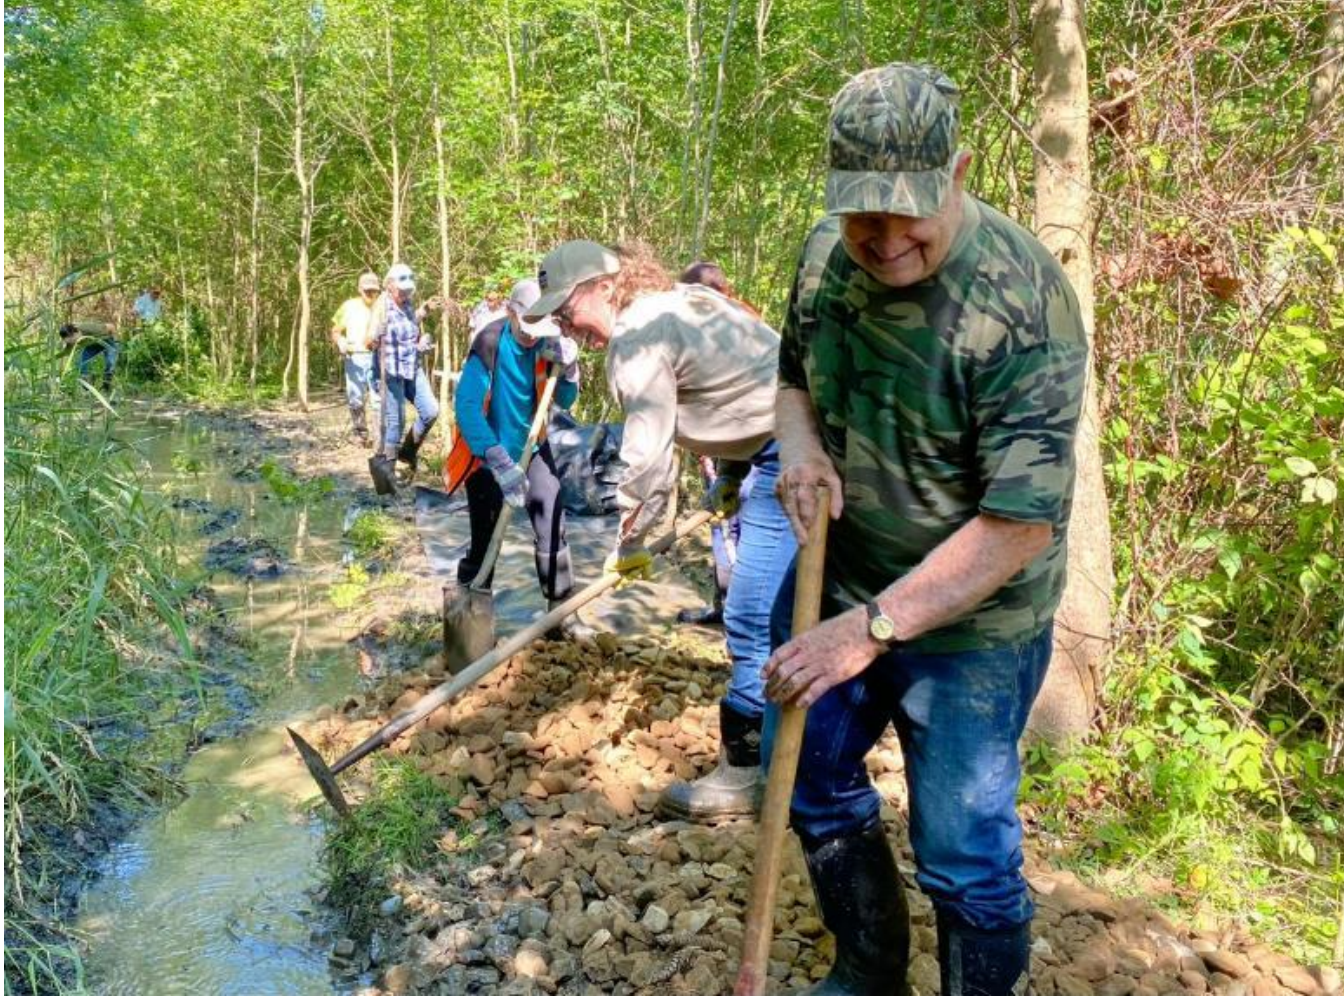
Landscape fabric was laid down, followed by a thick layer of rock.

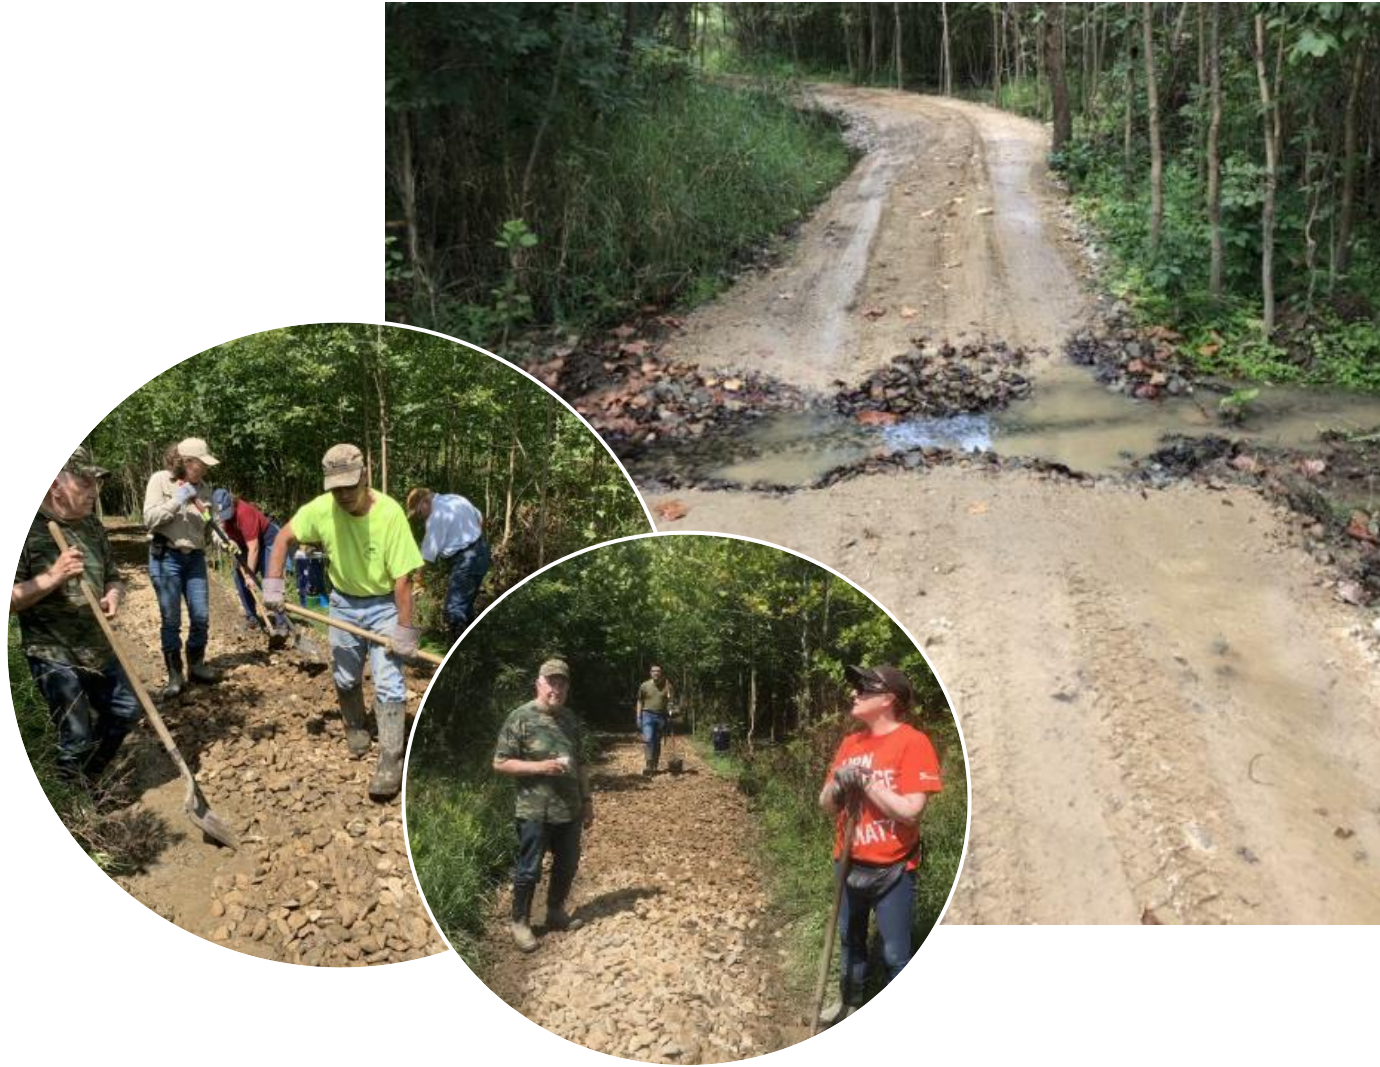
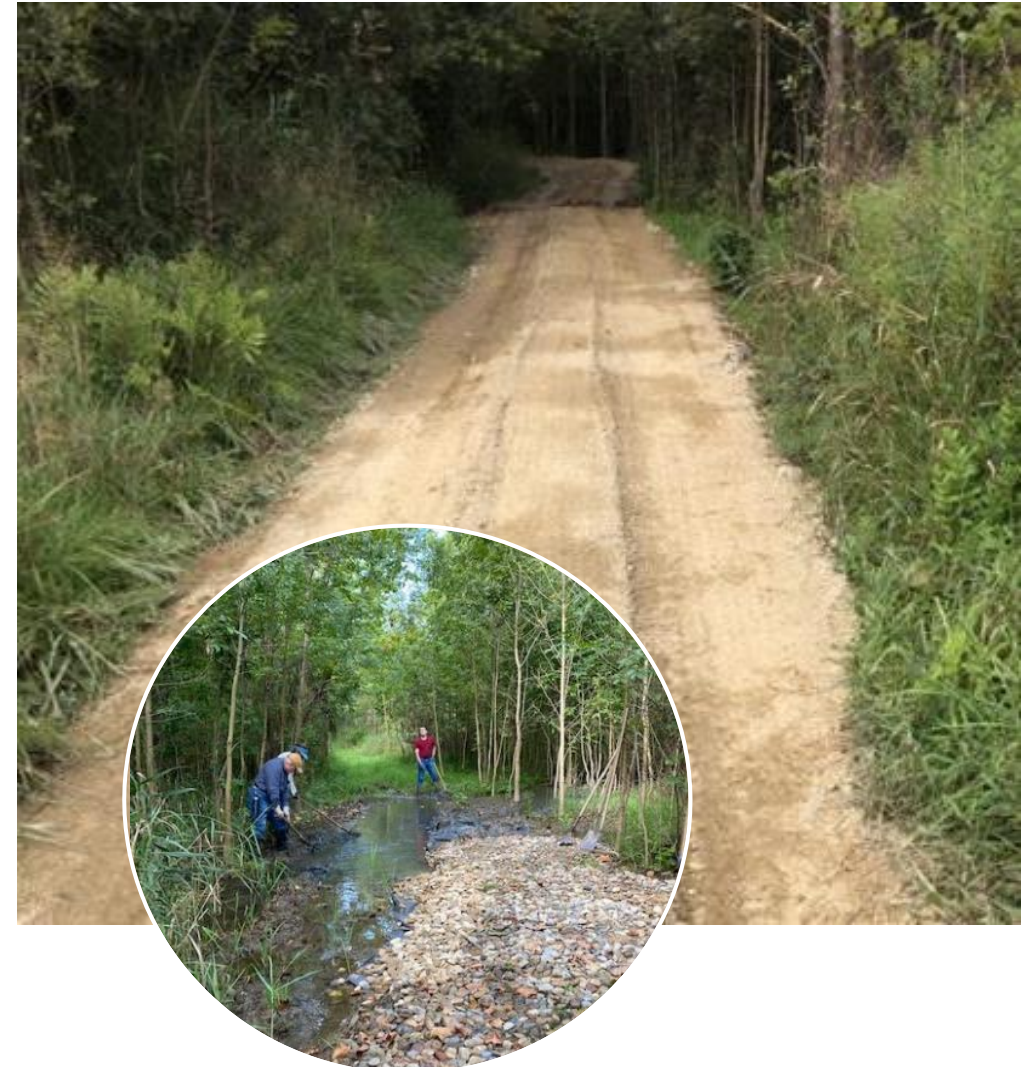
Channels were created to let water flow to the other side and then trail mix was added on top to finish.

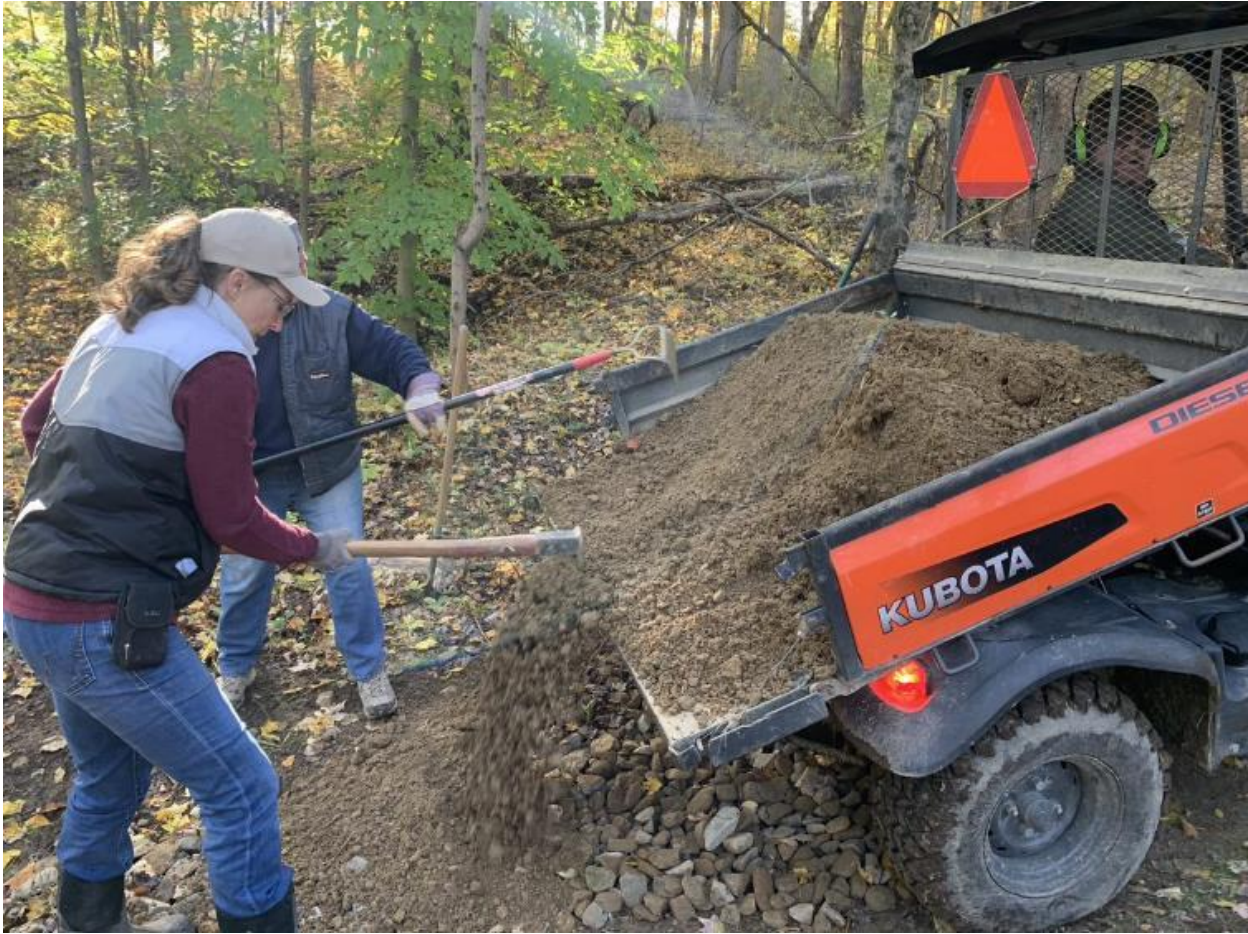
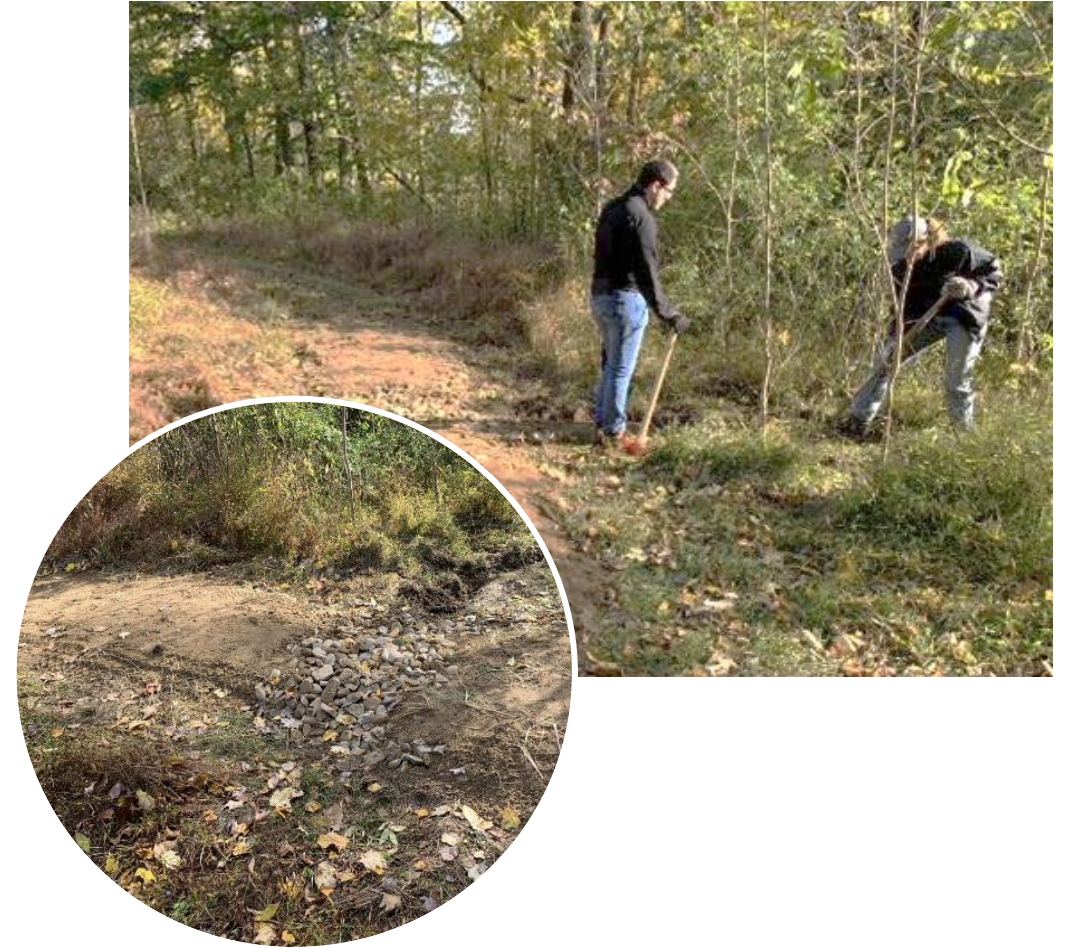
Trail Hardening Behind Fabio Barn

OHC helped repair the muddy areas by adding material and creating drains.
